# Hermosa Beach Storm Drain Master Plan

June, 2018

**Schaaf & Wheeler**  
CONSULTING CIVIL ENGINEERS

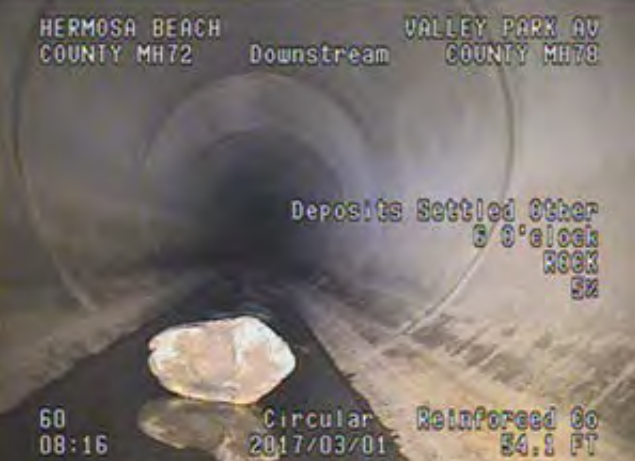
Distance	Fault Observation	Picture
54.1	<p><b>Deposits Settled Other</b>  <b>Position: 6</b>  <b>Severity: None</b>  <b>Remarks: ROCK</b></p>

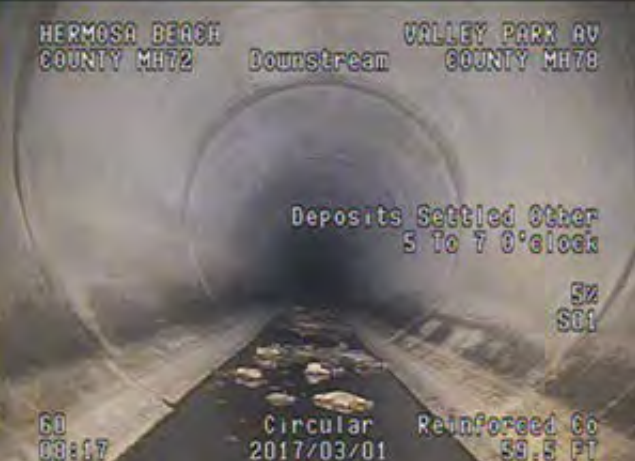
59.5	<p><b>Deposits Settled Other</b>  <b>Position: 5 To 7</b>  <b>Severity: None</b>  <b>Cont Defect: S01</b>  <b>Remarks:</b></p>

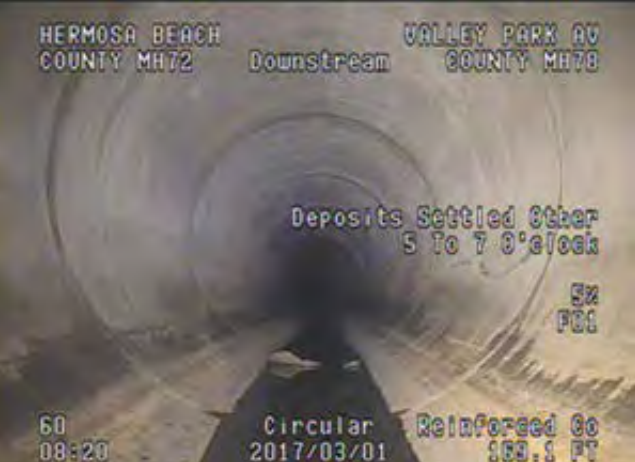
167.2	<p><b>Deposits Settled Other</b>  <b>Position: 5 To 7</b>  <b>Severity: None</b>  <b>Cont Defect: F01</b>  <b>Remarks:</b></p>

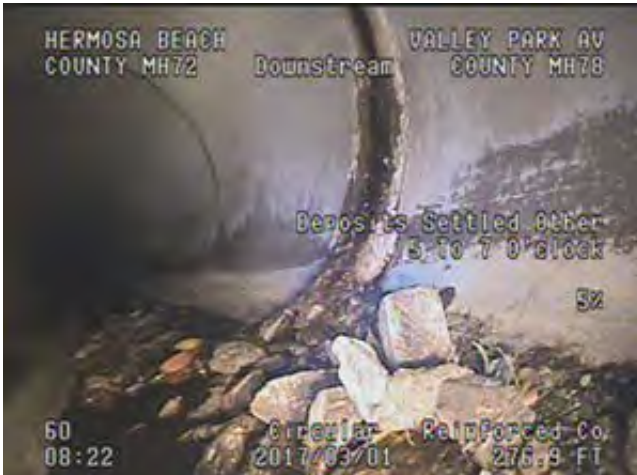
Distance	Fault Observation	Picture
276.9	<p><b>Deposits Settled Other</b>  <b>Position: 5 To 7</b>  <b>Severity: None</b>  <b>Cont Defect: S02</b>  <b>Remarks:</b></p>

<p>HERMOSA BEACH COUNTY MH72      Downstream      VALLEY PARK AV COUNTY MH78</p> <p>Deposits Settled Other 5 To 7 O'clock</p> <p>SZ</p> <p>60      Circular      Reinforced Co 08:22      2017/03/01      276.9 FT</p>

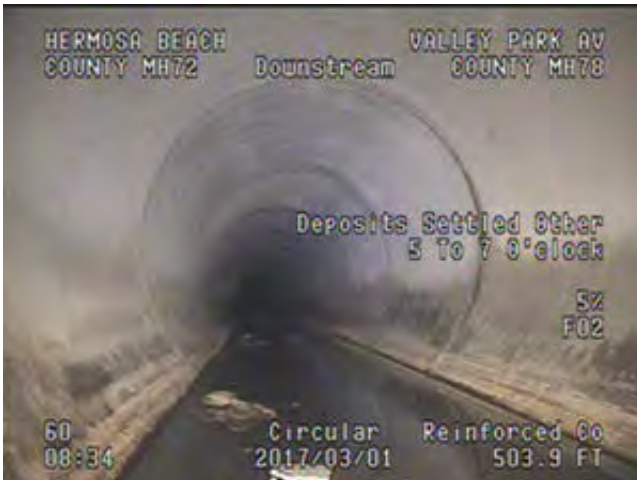
503.9	<p><b>Deposits Settled Other</b>  <b>Position: 5 To 7</b>  <b>Severity: None</b>  <b>Cont Defect: F02</b>  <b>Remarks:</b></p>

<p>HERMOSA BEACH COUNTY MH72      Downstream      VALLEY PARK AV COUNTY MH78</p> <p>Deposits Settled Other 5 To 7 O'clock</p> <p>SZ F02</p> <p>60      Circular      Reinforced Co 08:34      2017/03/01      503.9 FT</p>

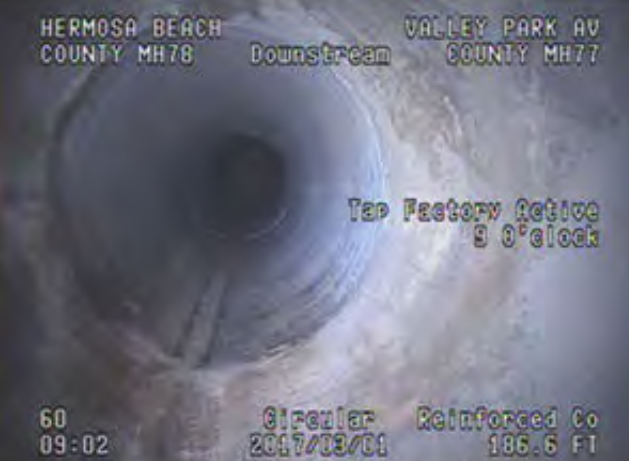
Distance	Fault Observation	Picture
186.6	<p><b>Tap Factory Active</b>  <b>Position: 9</b>  <b>Severity: None</b>  <b>Size: 4</b></p>

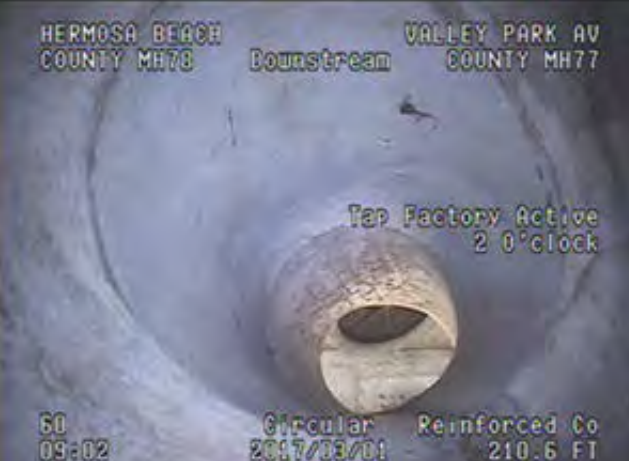
210.6	<p><b>Tap Factory Active</b>  <b>Position: 2</b>  <b>Severity: None</b>  <b>Size: 18</b></p>

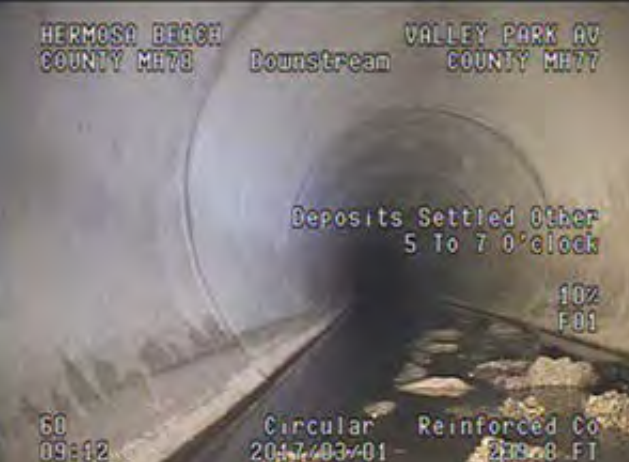
239.8	<p><b>Deposits Settled Other</b>  <b>Position: 5 To 7</b>  <b>Severity: None</b>  <b>Cont Defect: F01</b>  <b>Remarks:</b></p>

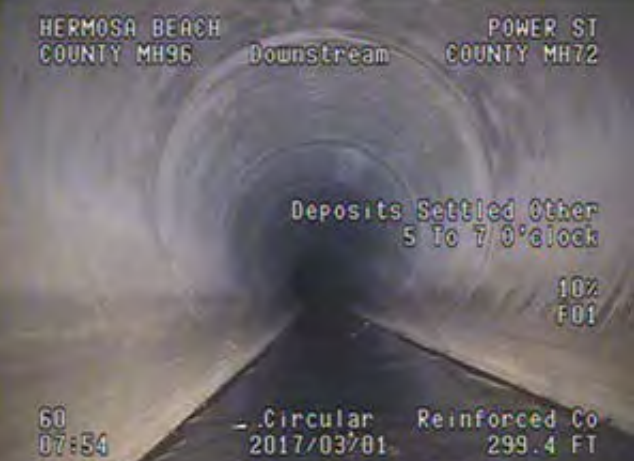
Distance	Fault Observation	Picture
299.4	<p><b>Deposits Settled Other</b>  <b>Position: 5 To 7</b>  <b>Severity: None</b>  <b>Cont Defect: F01</b>  <b>Remarks:</b></p>
