### **PHASE I ENVIRONMENTAL SITE ASSESSMENT**

**PHASE I  
ENVIRONMENTAL SITE ASSESSMENT**

**Hermosa Beach Hotel & Mixed Use Project**

3-31 Pier Avenue, 1212-1286 The Strand, and 20-32 13th Street  
Hermosa Beach, California 90254

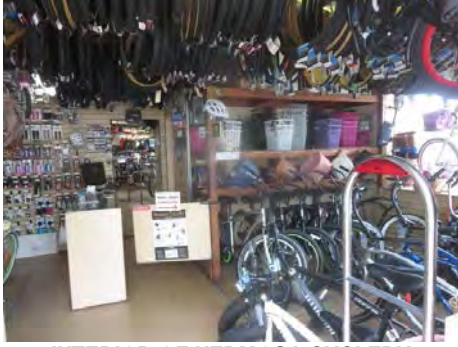
The north side, two story, commercial building fronting 13th Street was occupied by Hermosa Cyclery. This tenant uses small quantities of cleaners and lubricants for bicycle repair and maintenance operations. Based on the small quantities of these materials and the lack of any conduits to the subsurface, ES does not consider this current use to be a threat to the environmental integrity of the subject property.

**INTERIOR OF HERMOSA CYCLERY**

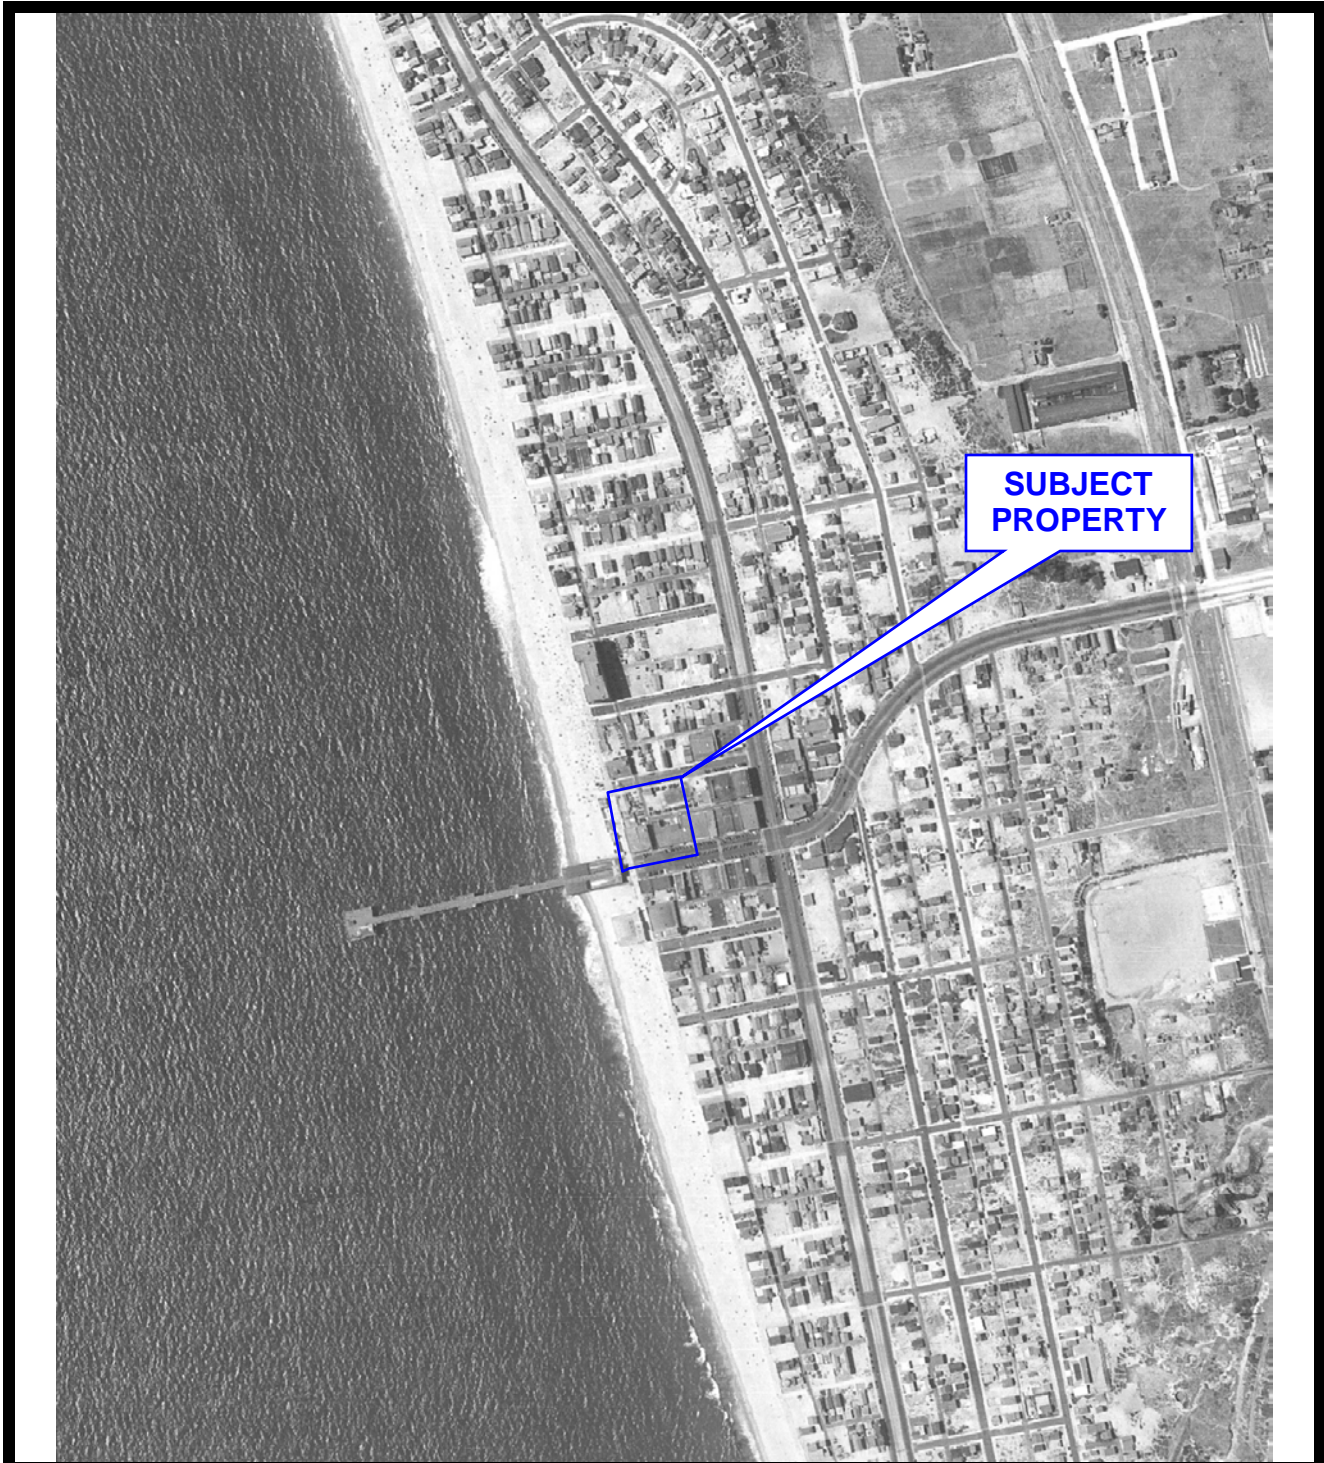
The only significant difference in the 1938 and 1947 photographs from the 1928 photograph was the two-story portion of the west subject property building was visible in both of these photographs. There were no obvious signs of the storage or disposal of hazardous materials on the subject property in these photographs.

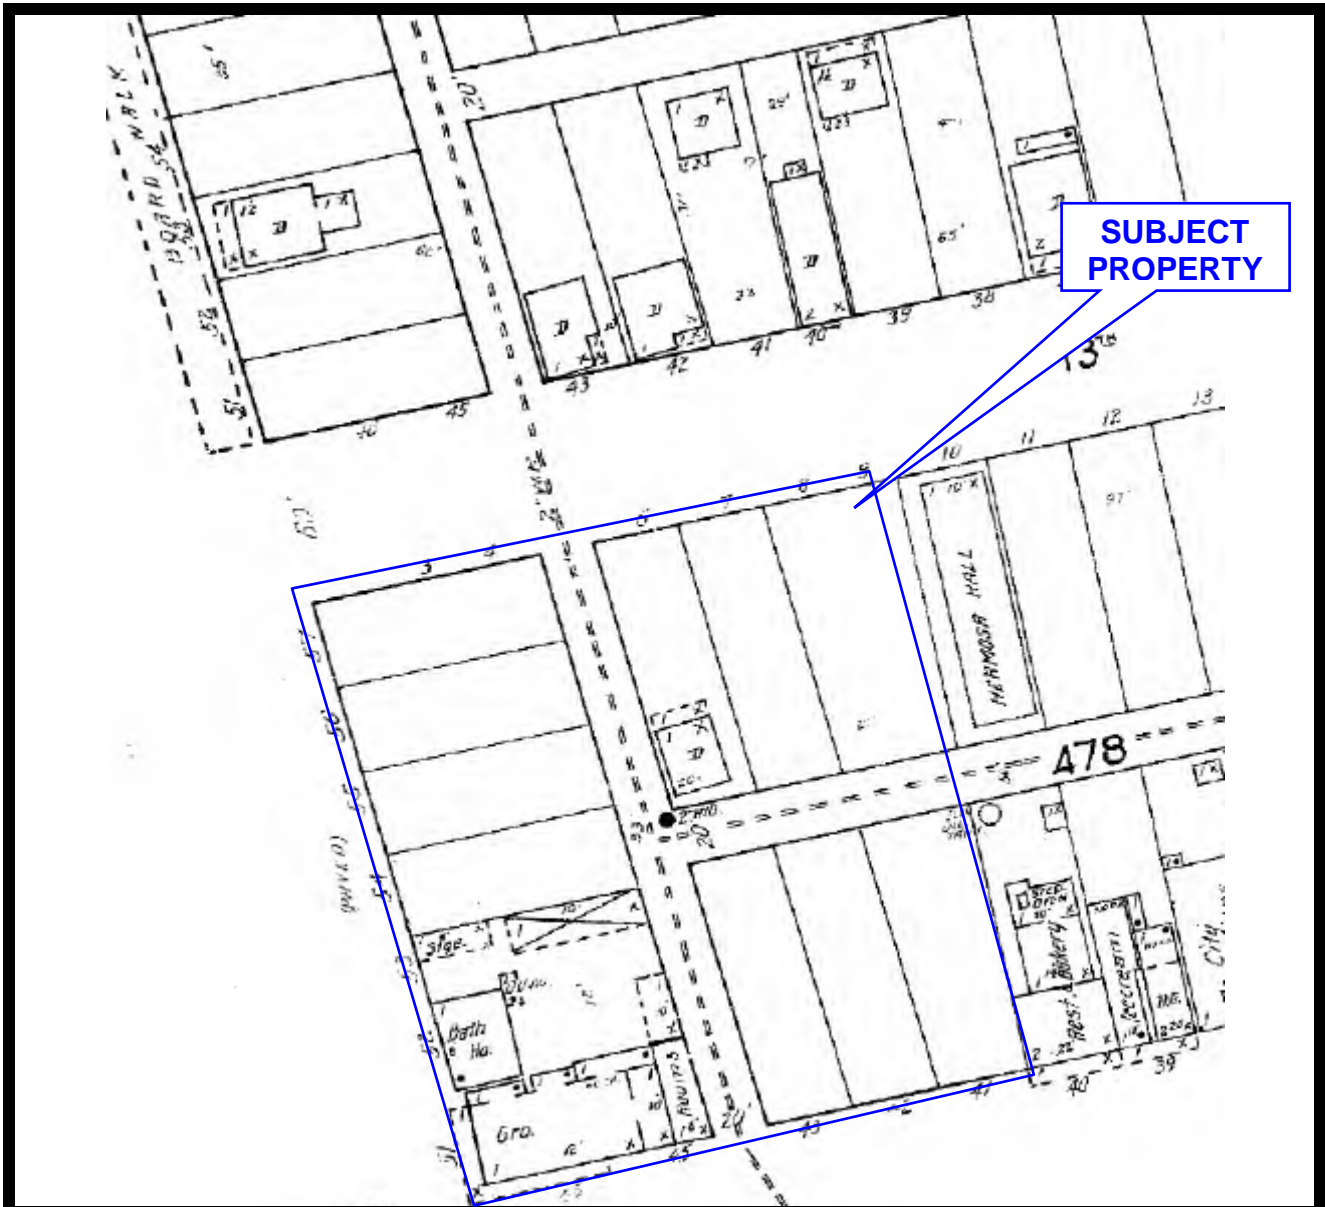
Item: Sanborn Fire Insurance Map
Date: 1912
Scale: None
Project: 3-31 Pier Avenue, 1212-1286 The Strand, and 20-32 13th Street ESA
Project Number: ES15-001

There were no significant differences on the subject property or surrounding sites in the 1912 map from the 1908 map. The building in the southwest corner of the subject property was listed as a grocery store. There were no obvious signs of the storage or disposal of hazardous materials on the subject property in this map.
