# City of Hermosa Beach

**DATE:** Monday, August 16, 2021  
**TO:** Honorable Mayor and Members of the City Council  
**FROM:** City Manager and Public Works staff  
**SUBJECT:** Temporary Beach Access Routes Report and Pilot Program

### Temporary Beach Access Routes

**Accessibility Evaluation**

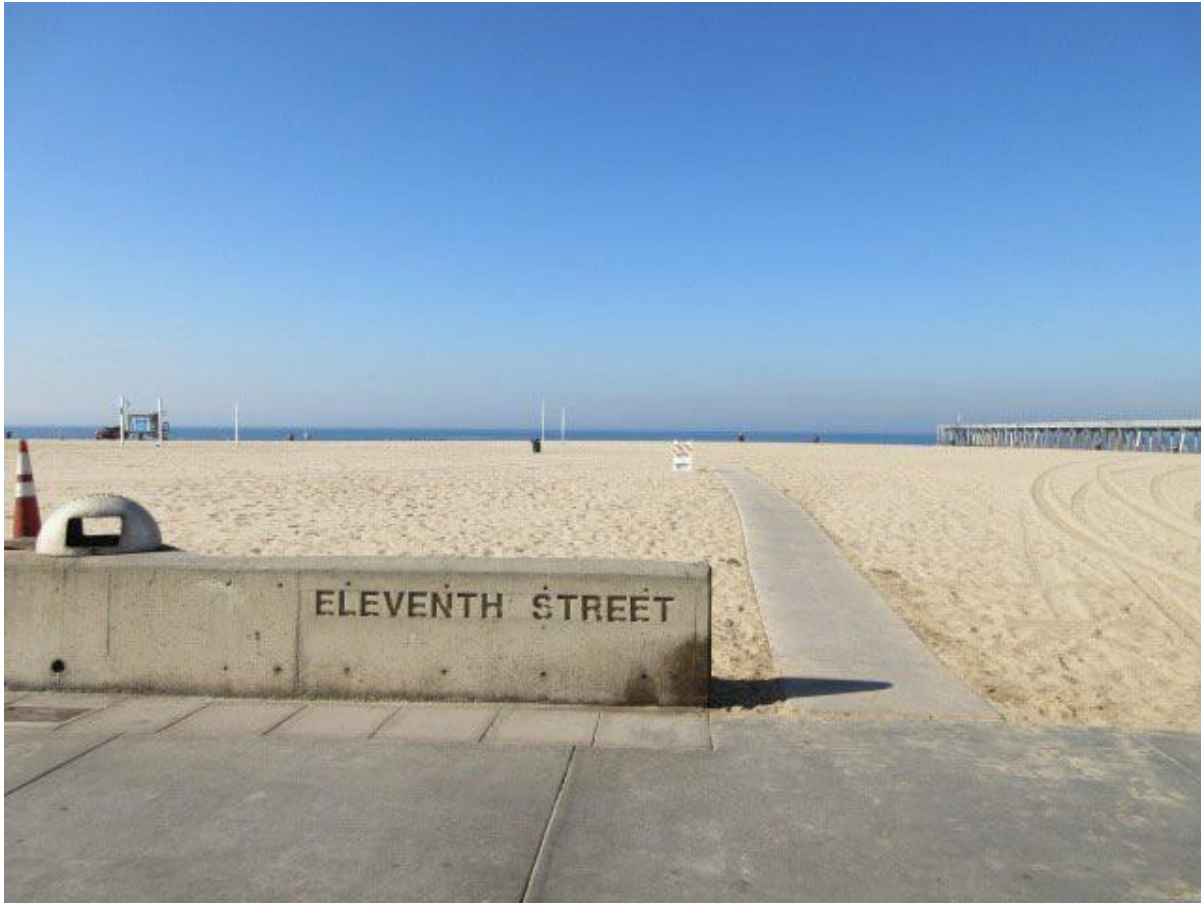
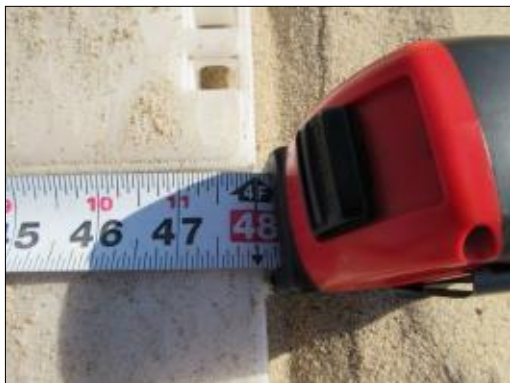
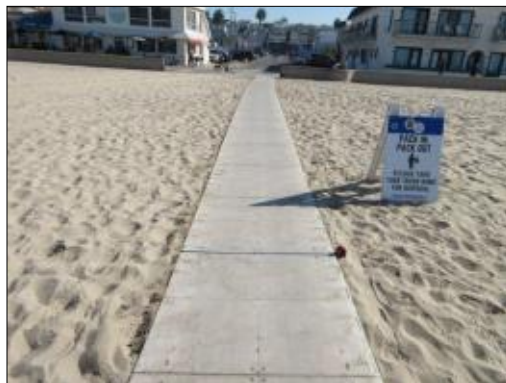
**Finding #1 Additional Finding Photos**

At the time of the original inspection there are a total of 30 (48" x 48") beach tiles that make up the roughly 105 feet existing beach path.

The path is comprised of 24 beach tiles and the resting space, or Vista Point, at the end is comprised of 6 beach tiles.

When a wheelchair user is using this temporary beach path, the width of the route does not accommodate two directions of travel.

Electric/power wheelchairs can measure up to 40 inches or more depending on the weight of the wheelchair user. Therefore, when a wheelchair user approaches another individual(s) there is no room to pass. Having a wider path will prevent attention being brought to the wheelchair user while utilizing the path and provides additional room to assist in preventing wheelchair users from running off the path and into the sand which may require assistance to get out of the sand and back on the path, again drawing attention and possible embarrassment to the wheelchair user.

The circulation path  
leads to a vista point.

While there are no approved code standards for beach access routes, the guidelines require the clear width to be a minimum 60 inches. With that said, it is understood the City wishes to have a path that accommodates two directions of travel simultaneously. Therefore, it is recommended the path be widened to 8 feet (96 inches) by adding an additional 24 (48" x 48") beach tiles.

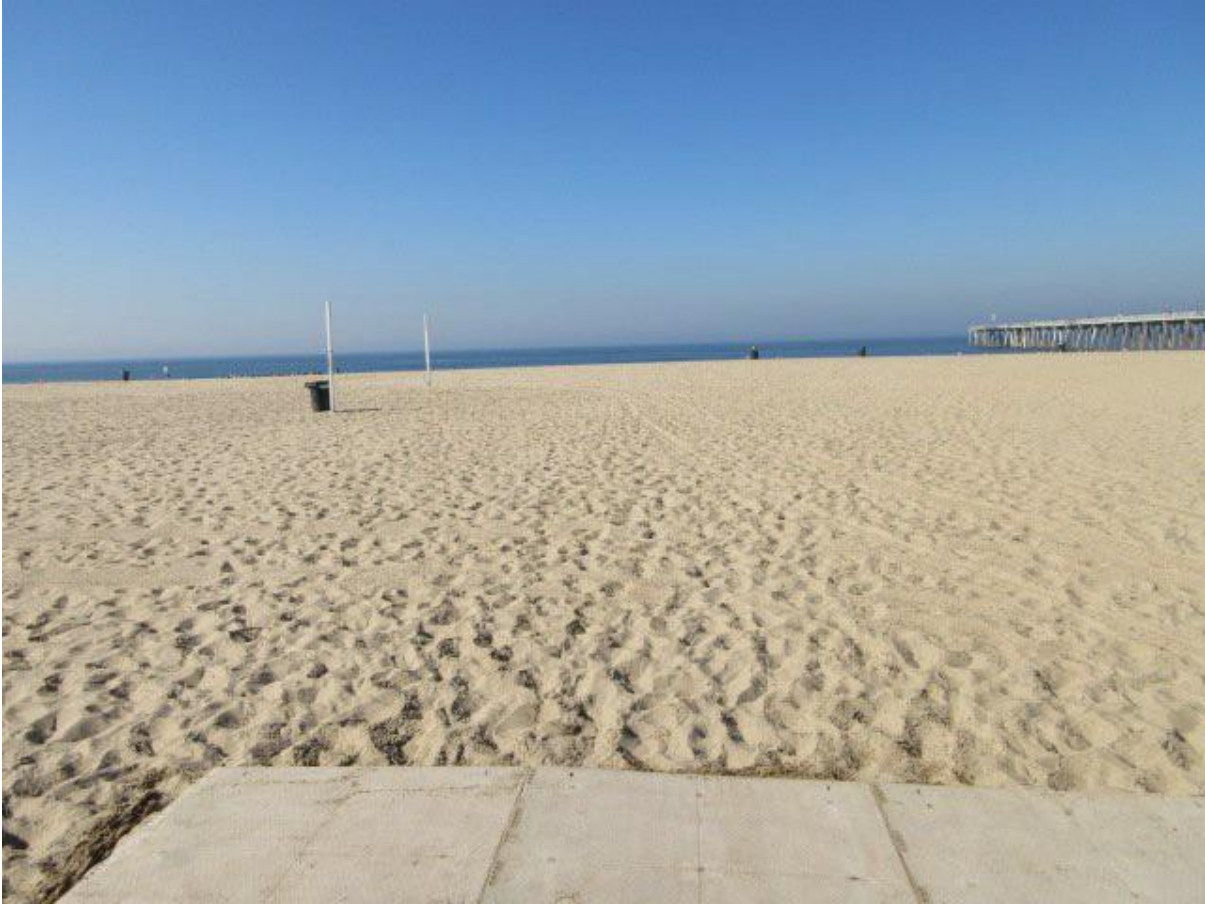
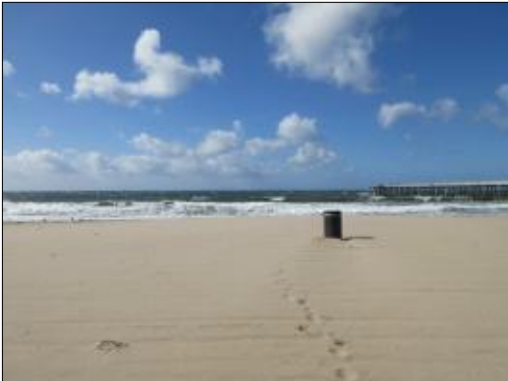
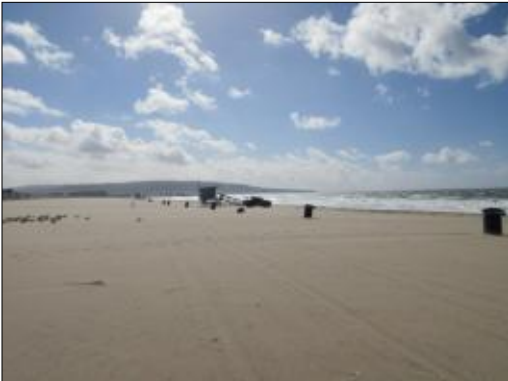
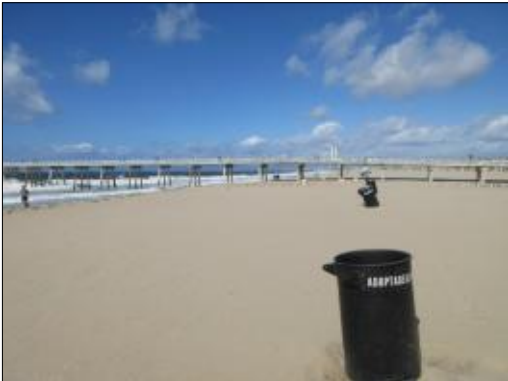
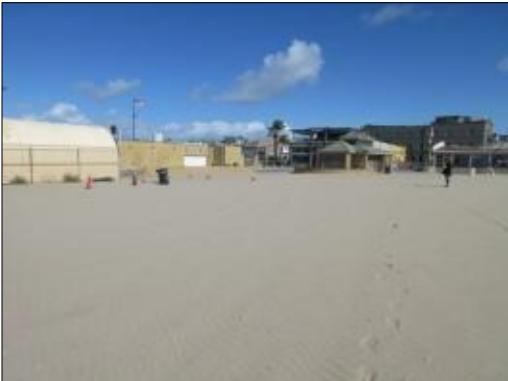
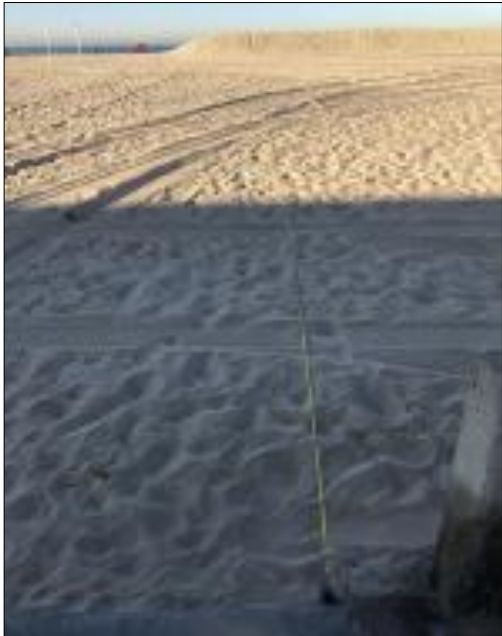
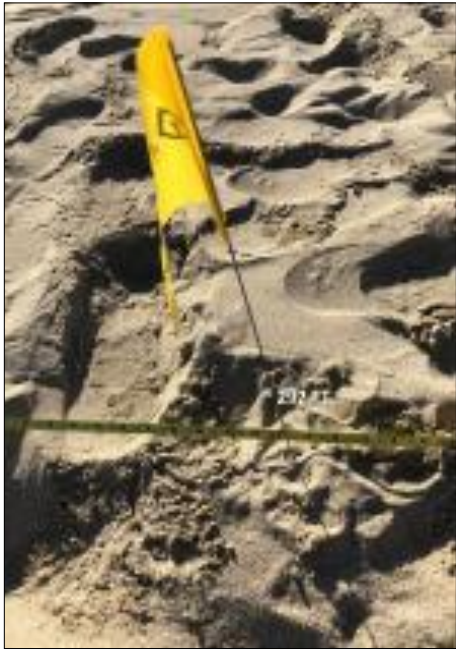
Finding #2 Additional Finding Photos

It has been proposed that the existing temporary accessible beach access route be extended closer to the ocean. However, there is a volleyball court within the projected alignment of the existing beach access route.

The additional beach tiles will create a hazard when placed too close to a sport court of any kind.

To avoid proximity to the sport courts, an alternative route with an equivalent view of the ocean breaking onshore (at mean low tide) may be installed that measures approximately 275 feet from The Strand.

The proposed path is obstructed.

Several locations were considered and the location that offers the most amenities for a temporary accessible beach access route is located just south of the existing public restrooms at Pier Plaza. See the Site Sketch attached as Exhibit A to this report. Considerations for this location included but were not limited to: the proximity to the public restrooms, showers, the Pier, and public accommodations provided by nearby hotels, restaurants and retail locations at Pier Plaza.

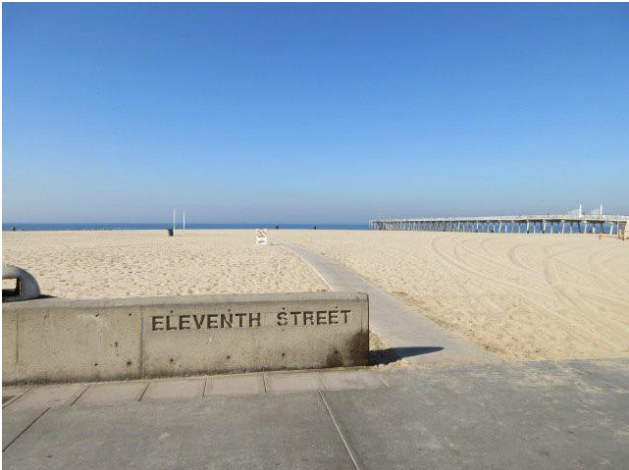
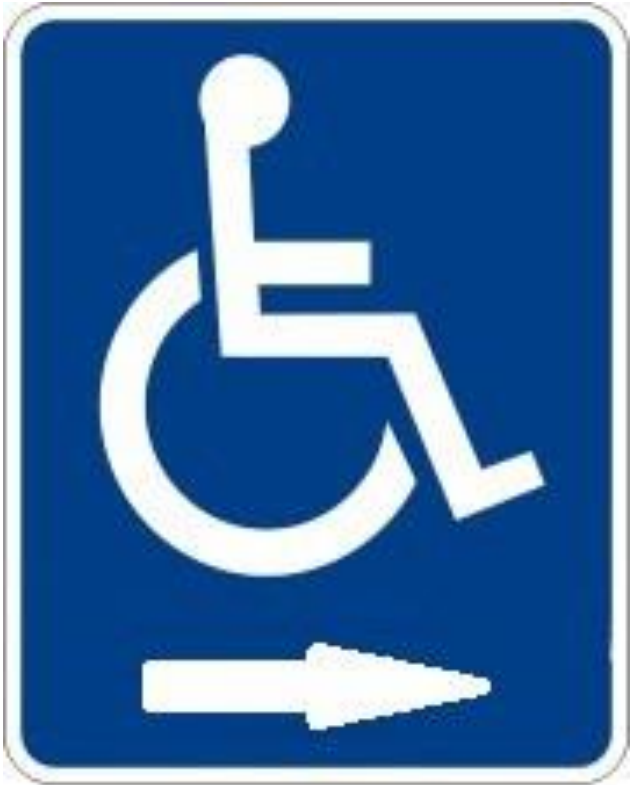
Finding #3 Continued

The existing temporary accessible beach access route is missing directional signage that identifies the location/direction of the accessible route of travel to the Vista Point.

Directional signage is missing.

Provide directional signage at The Strand that directs the public to the temporary accessible beach access route. Additional information may be provided on the sign, for example "Accessible Beach Path" may be added to the sign.

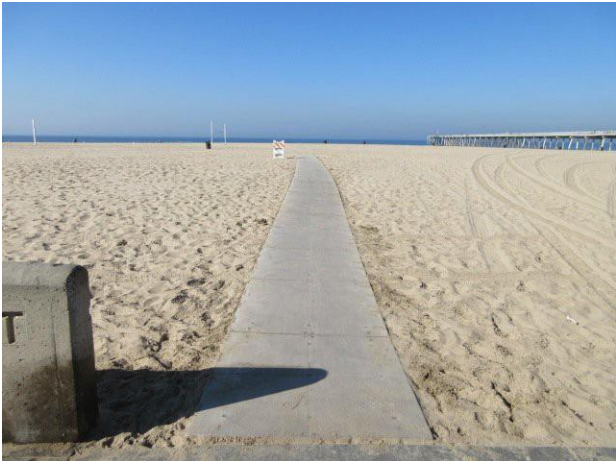
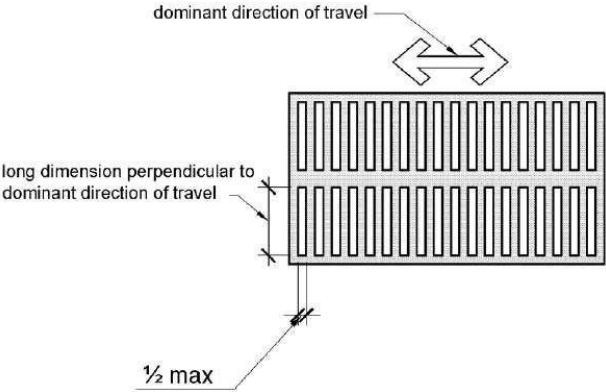
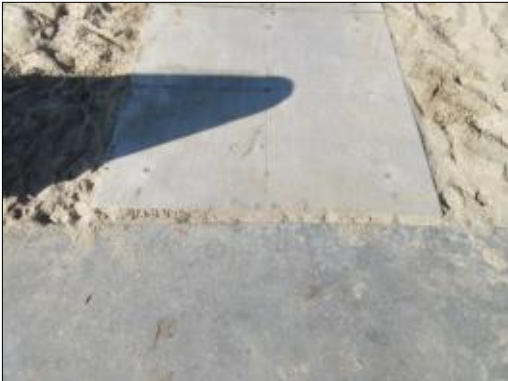
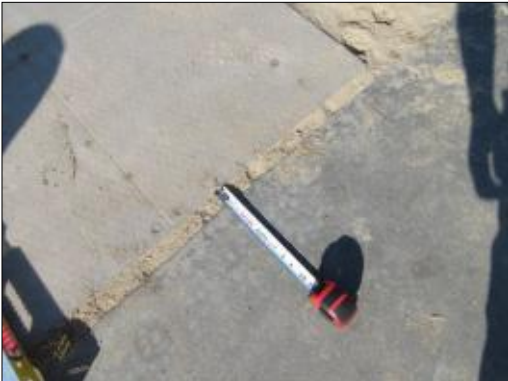
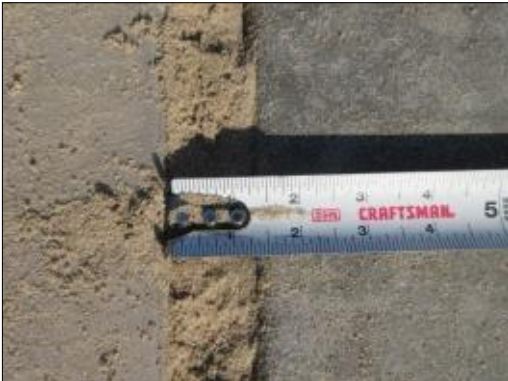
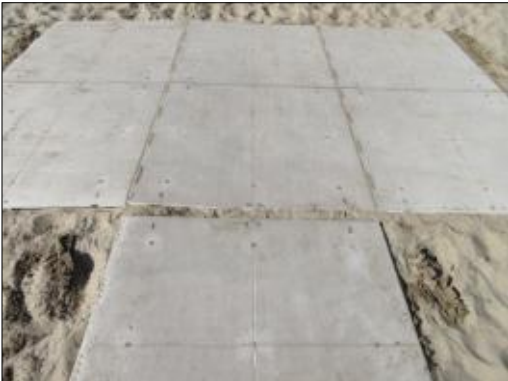
Finding #4 Continued

The gaps between panels and/or the edge of the concrete walk at the existing temporary accessible beach access route measured greater than 1/2 inch.

Openings in floor or ground surfaces shall not allow passage of a sphere more than 1/2 inch diameter. Elongated openings shall be placed so that the long dimension is perpendicular to the dominant direction of travel.

The gaps measured greater than 1/2 inch.

Relocate and maintain the panels leaving no gaps greater than 1/2 inch.

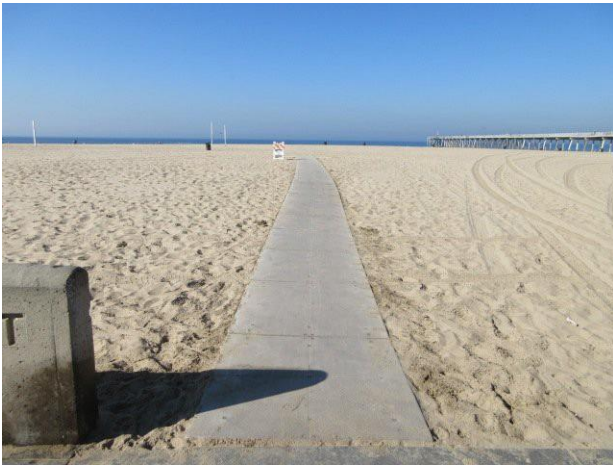
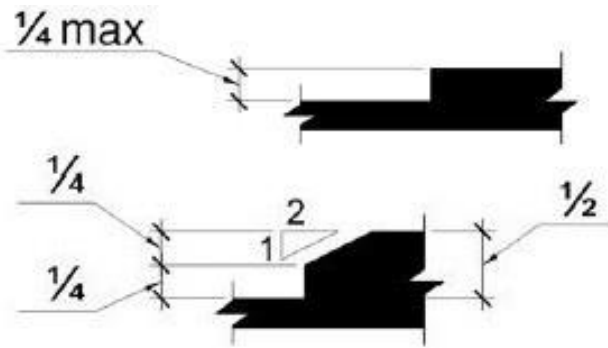
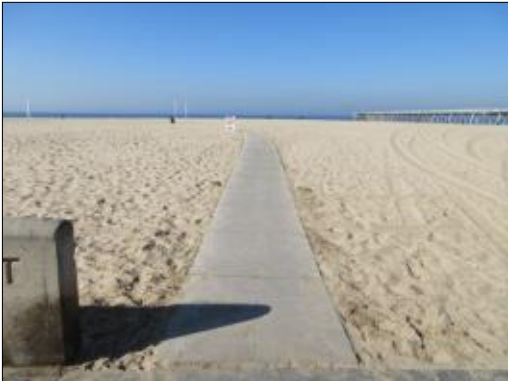
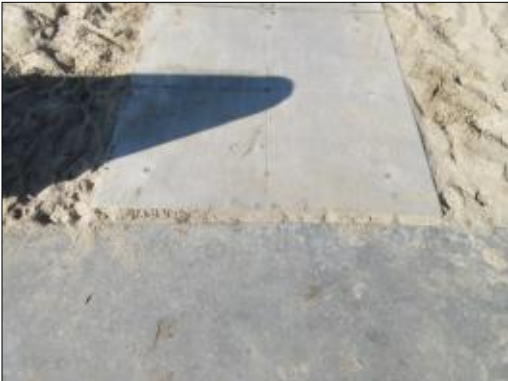
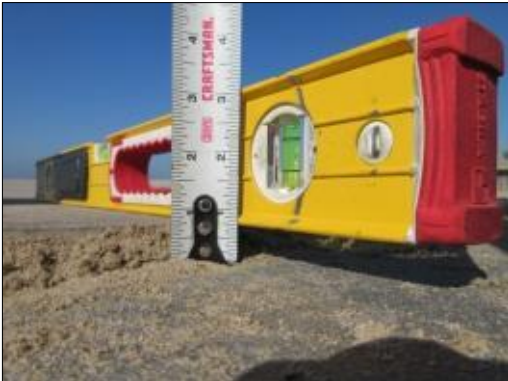
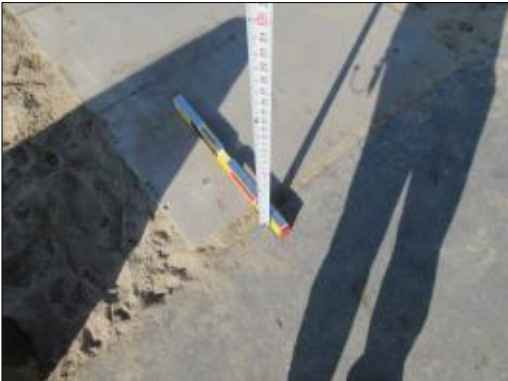
Finding #5 Additional Finding Photos

The existing temporary accessible beach access route contains abrupt vertical edges and/or variations over a 1/4 inch at the edge of The Strand.

Changes in level greater than 1/2 inch must be by way of a ramp.

Adjust the level of the panel(s) and maintain a route of travel free from changes in elevations greater than 1/4 inch.
