RE: SOIL ASSESSMENT REPORT
Manhattan Car Wash
300 South Sepulveda Boulevard
Manhattan Beach, California 90266
CLADPW File No. EP-1 012784-012981

EXECUTIVE SUMMARY

ATTACHMENT A
Current Site Photographs

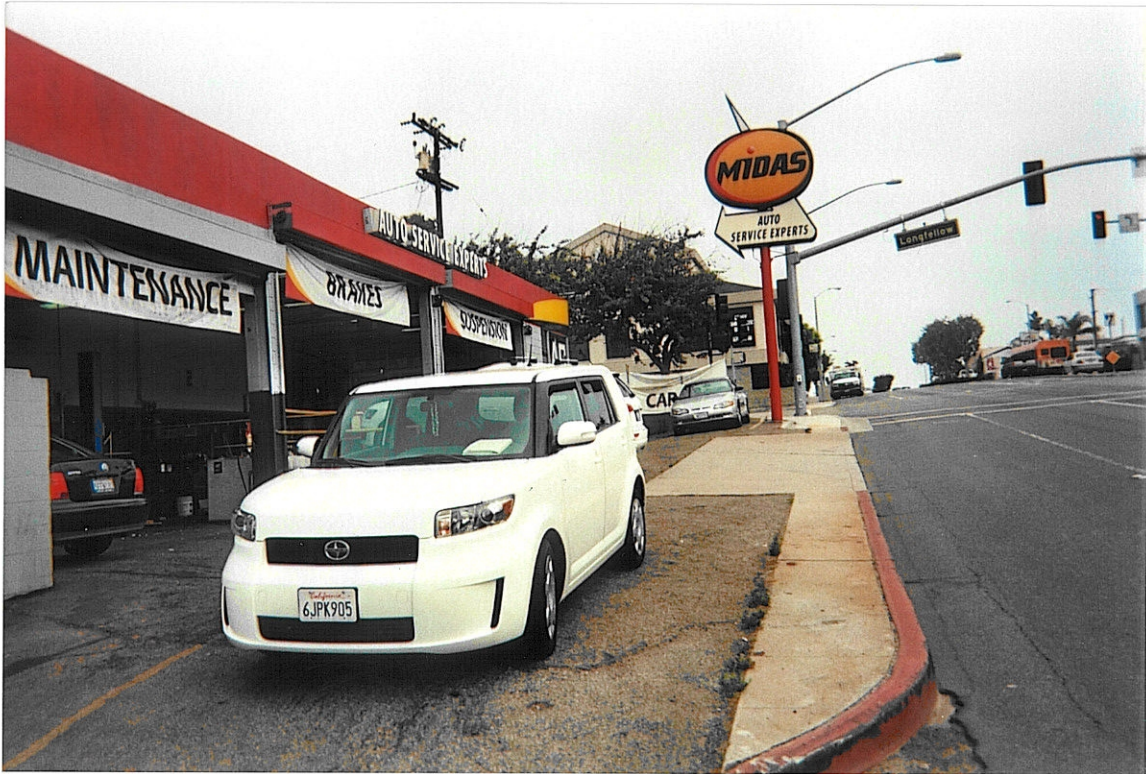
PHOTOGRAPH 1 – View looking north from the southeast corner of the Site. The three double-wide roll-up doors provide access to the service bays. A small office is at the north end of the building. The building in the distance is across Longfellow Avenue. Pacific Coast Highway is on the right.

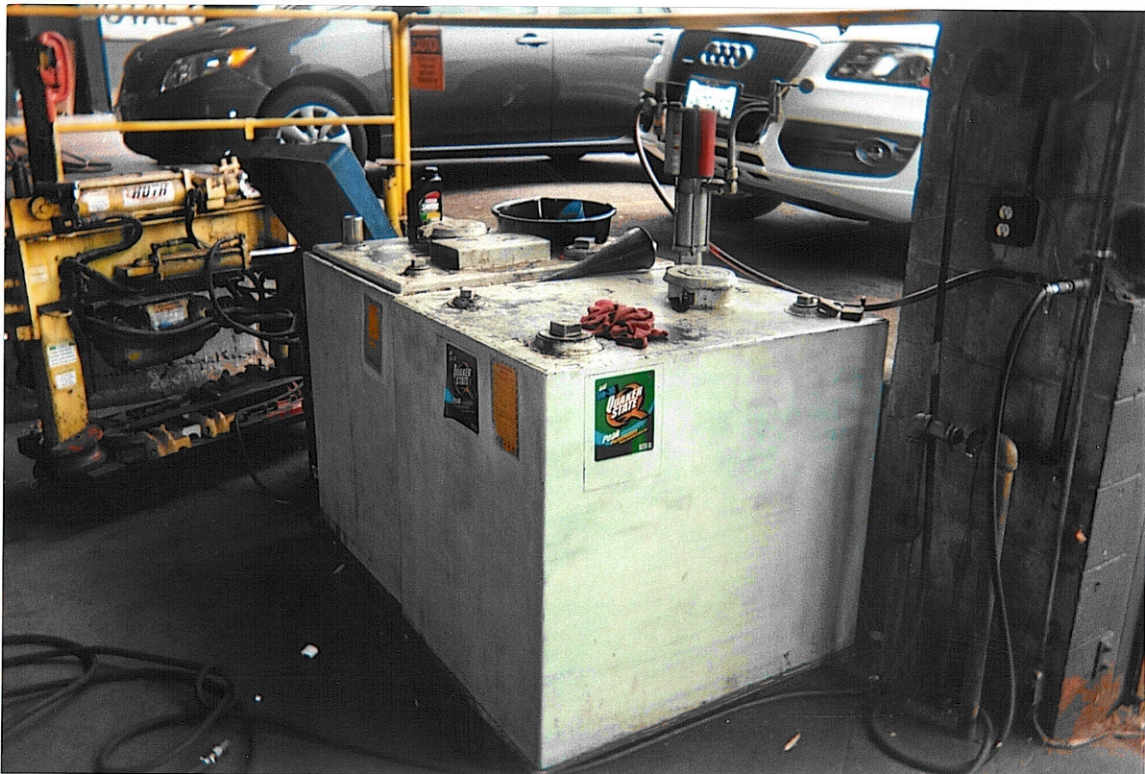
PHOTOGRAPH 2 – View of the two above ground storage tanks for new and used motor oil located in Bay 4. There is no drive in access to Bay 4. Equipment for tire mounting and balancing and a brake lathe are also in the Bay.

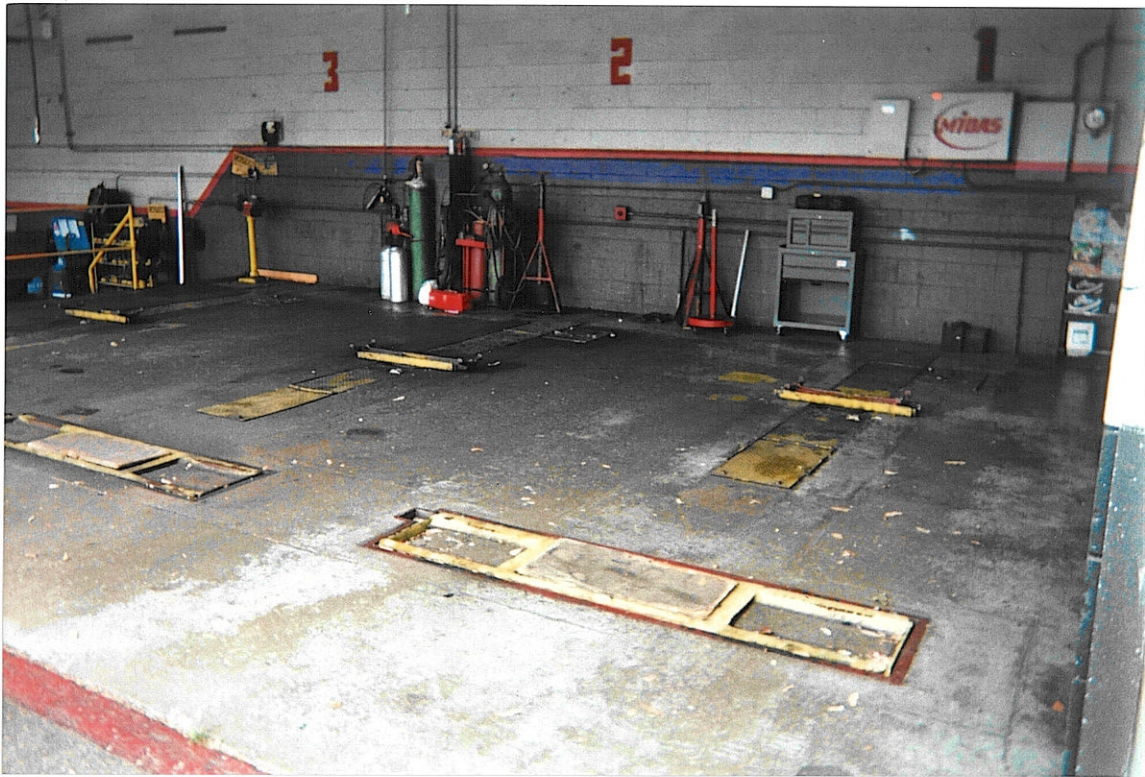
PHOTOGRAPH 3 – View looking west at service Bays 1, 2, and 3. The office area is to the right of the view. Each bay has an in-ground front-to-rear lift with a vault. The rear piston (in the foreground) is stationary. The front piston moves back and forth in an 8-foot deep concrete vault under the yellow steel plates. The front piston is under the yellow steel arm that crosses the vault. Metal steps down to Bays 4, 5 and 6 is seen at the left rear.

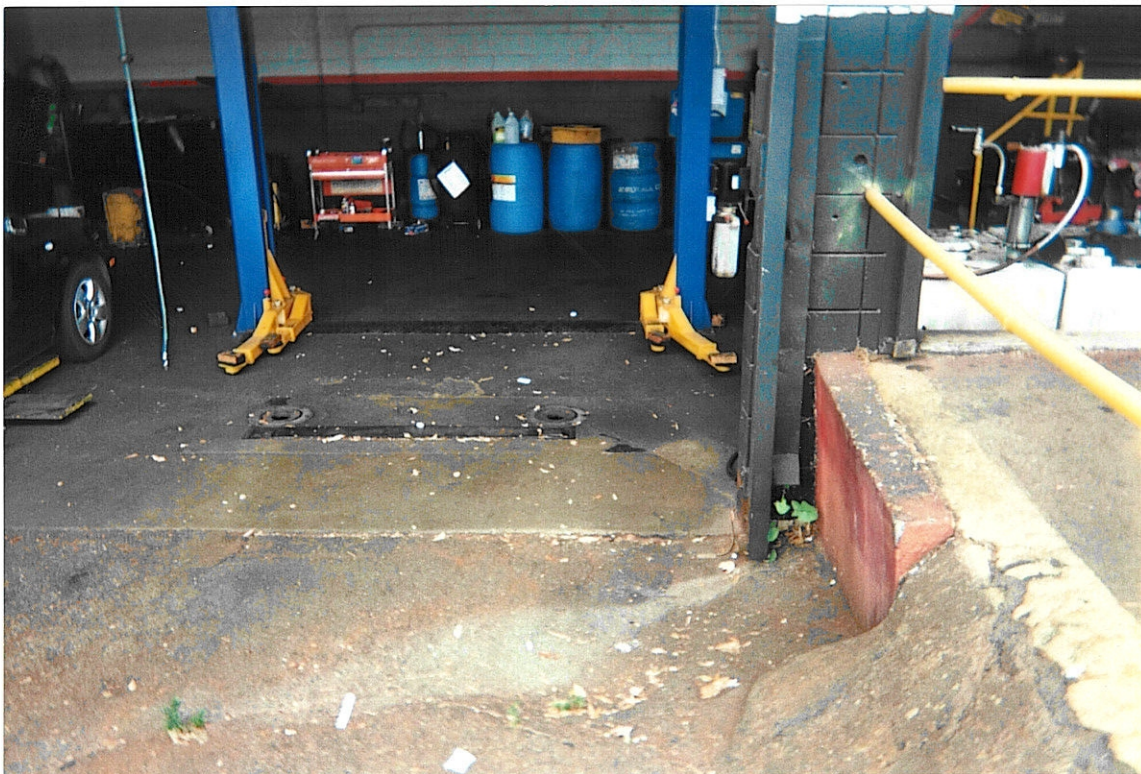
PHOTOGRAPH 4 – View looking west at Bay 5. An out-of-service dual-piston side-by-side in-ground lift is seen just inside the Bay. An above ground lift is behind the out-of-service lift. An operating side-by-side lift is present in Bay 6 to the left of the view. 55-gallon drums for new and used coolant and used oil filters are along the back wall. Bay 4 is to the right.

Areas of potential concern at the Site include the past and present storage and use of petroleum products and hazardous materials and the storage and disposal of petroleum and hazardous wastes, the presence of one out-of-service in-ground hydraulic lift and four active lifts. The Site occupant was observed to handle petroleum products and hazardous materials appropriately and to generate and properly dispose of wastes; however, historical activities cannot be documented. It is not known if the in-ground lift-vaults for the three front-to-rear lifts had accumulated fluids that may have leaked. Mr. Baer stated that the lift vaults are typically cleaned once a year. It is not known if the one out-of-service in-ground lift had leaked; however, lifts are typically taken out-of-service due to a leak or other malfunction.

Based on the information reviewed and summarized, it is the professional opinion of Jacob & Hefner Associates, Inc. that this assessment has revealed no evidence of recognized environmental conditions, as previously defined, at the Site except for the presence of one out-of-service side-by-side in-ground lift.

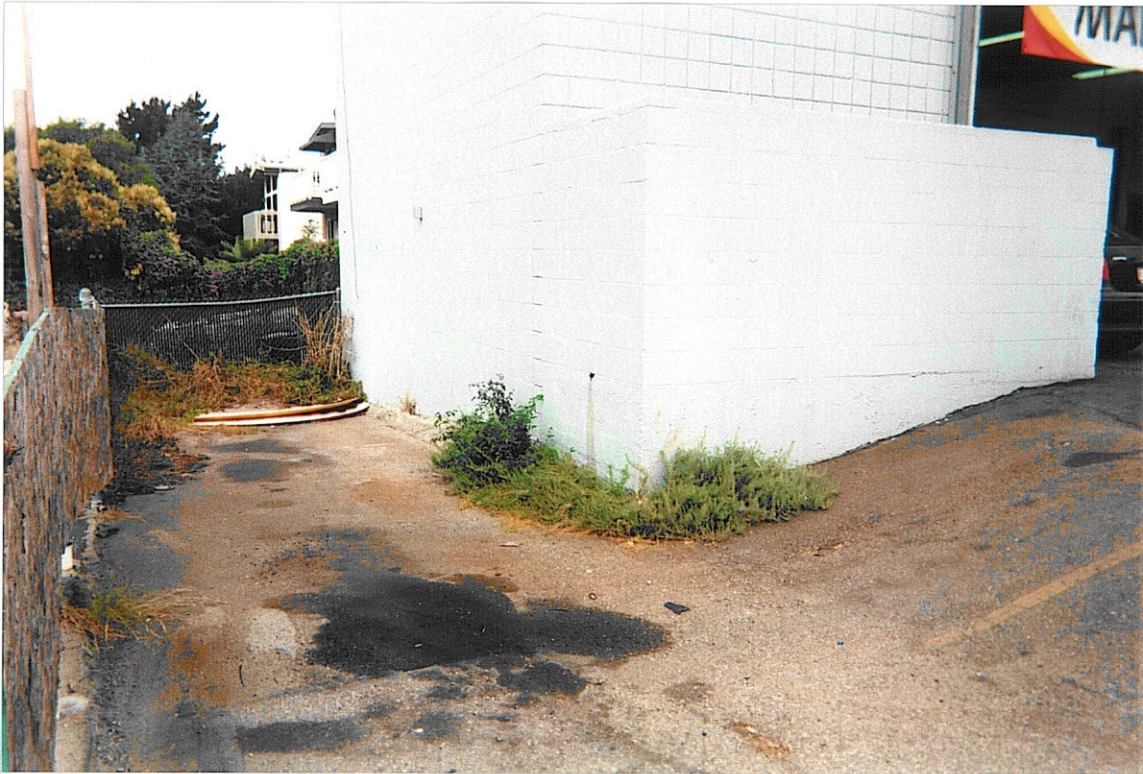
PHOTOGRAPH 5 – View looking west at the south side of the Site. The approximate 5-foot wide area is part of the vacated alley that is still present behind the houses in the distance. The vacant land beyond the fence appears to be part of a larger vacant lot south of the Site. A wall on the right is the trash enclosure at the corner of the building.

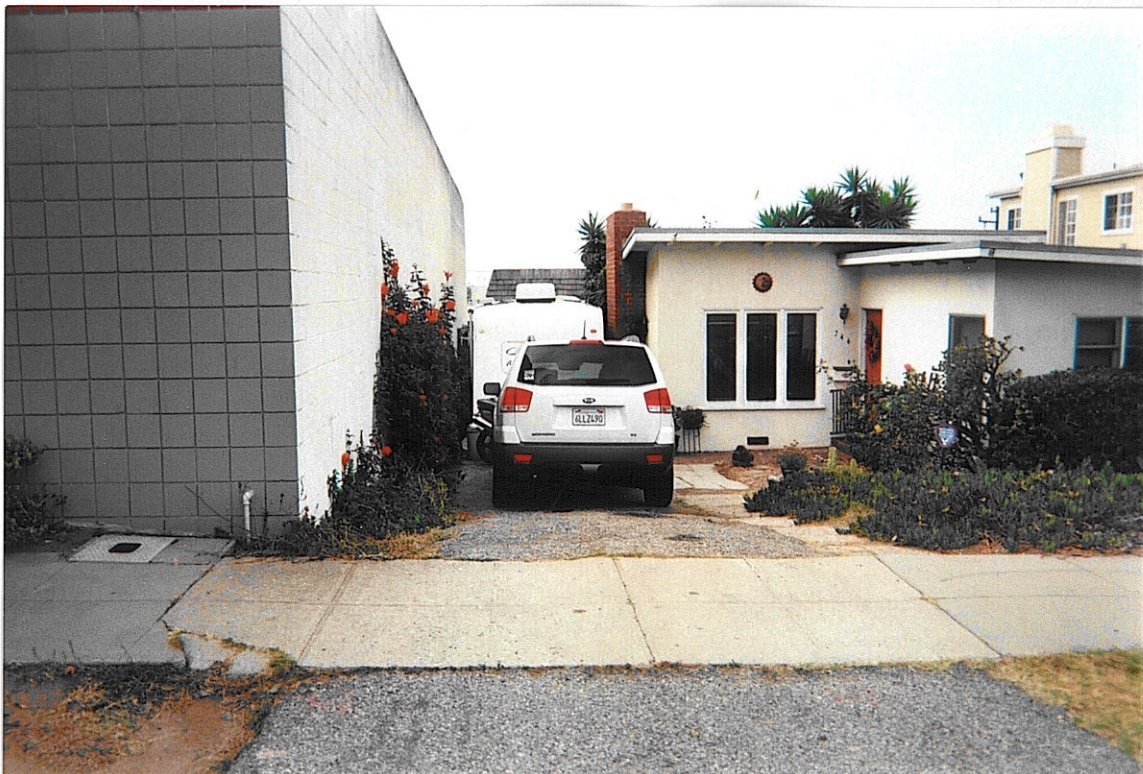
PHOTOGRAPH 6 – View looking south at the rear (west side) of the Site and the adjacent residence. The building is along the lot line.
