# Hermosa Beach Storm Drain Master Plan

June, 2018

**Schaaf & Wheeler**  
CONSULTING CIVIL ENGINEERS

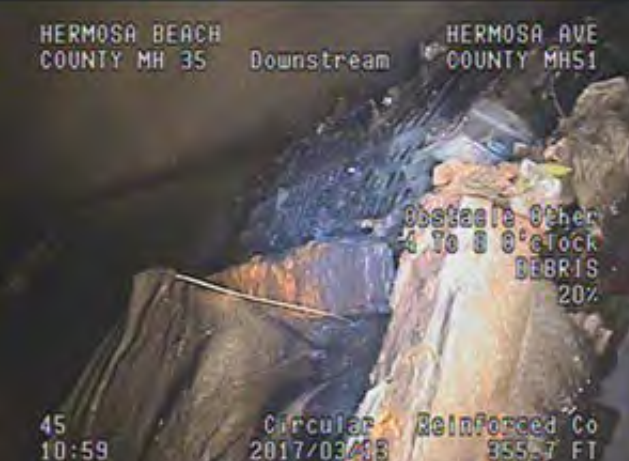
355.7	<p><b>Obstacle Other</b>  <b>Position: 4 To 8</b>  <b>Severity: None</b>  <b>Remarks: DEBRIS</b></p>

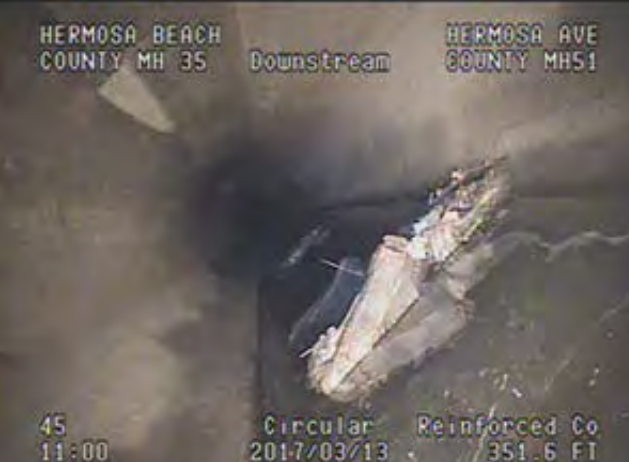
355.7	<p><b>Picture Number: 2</b>  <b>Obstacle Other</b>  <b>Position: 4 To 8</b></p>

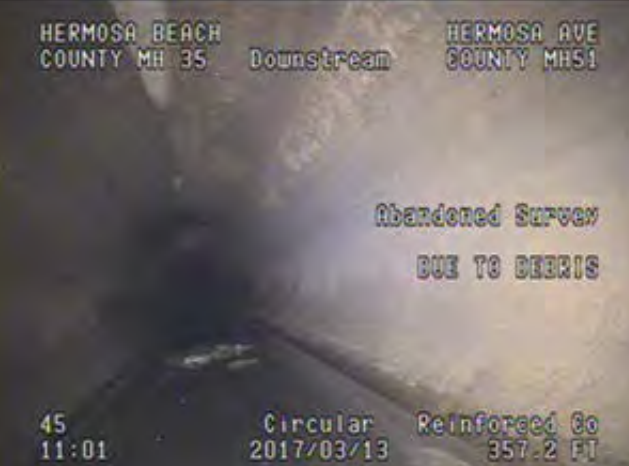
Distance	Fault Observation	Picture
357.2	<p style="text-align: center;">Abandoned Survey Severity: None Remarks: DUE TO DEBRIS</p>

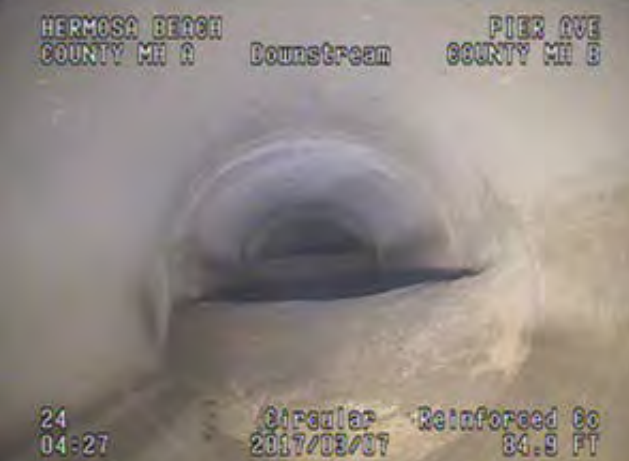
<p>HERMOSA BEACH COUNTY MH A Downstream PIER AVE COUNTY MH B                  Obstacle Other 3 To 9 o'clock CEMENT WALL (BULKHEAD?) 50%                  24 04:27 Circular 2017/03/07 Reinforced Co 89.7 FT</p>

Distance	Fault Observation	Picture
89.7	<p>Picture Number: 2  Obstacle Other  Position: 3 To 9</p>

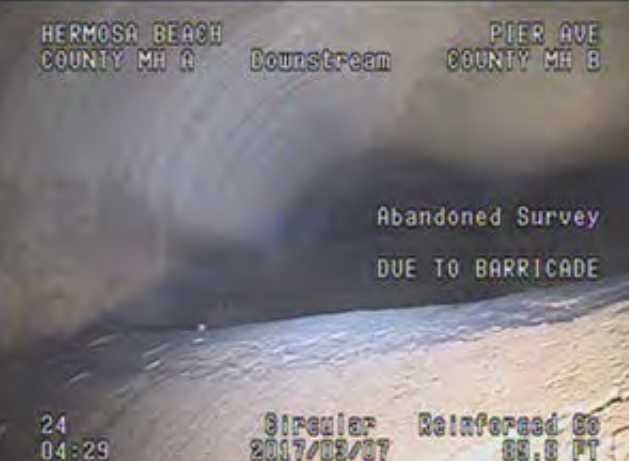
89.8	<p>Abandoned Survey  Severity: None  Remarks: DUE TO BARRICADE</p>

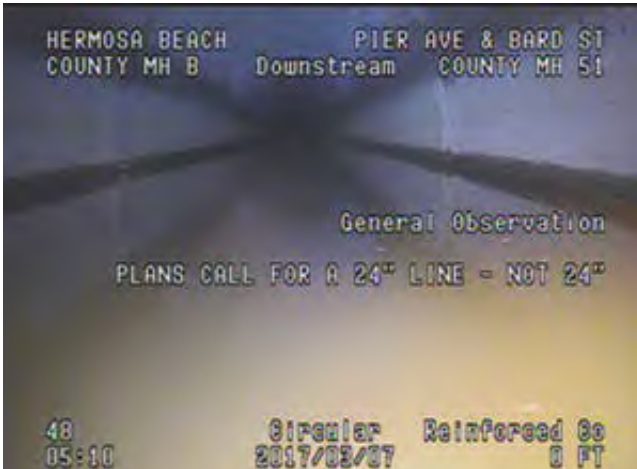
<p>HERMOSA BEACH COUNTY MH B PIER AVE &amp; BARD ST Downstream COUNTY MH 51  General Observation  PLANS CALL FOR A 24" LINE - NOT 24"  48 05:10 Circular 2017/03/07 Reinforced Co 0 FT</p>

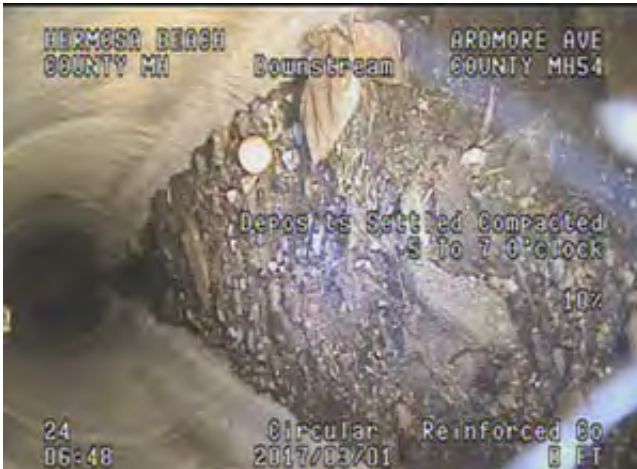
<p>HERMOSA BEACH COUNTY MH Downstream ARDMORE AVE COUNTY MH54                  Deposits Settled Compacted 5 to 7 O'clock 102                  24 06:48 Circular 2017/03/01 Reinforced Co 0 FT</p>

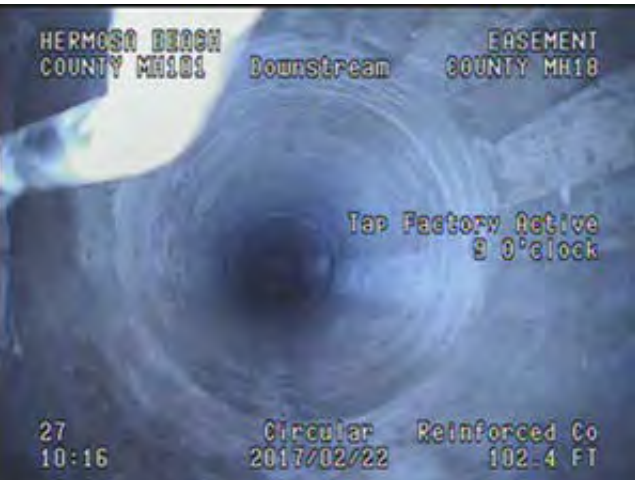
<p>HERMOSA BEACH COUNTY MH101 Downstream EASEMENT COUNTY MH18</p> <p style="text-align: right;">Tap Factory Active 9 o'clock</p> <p>27 10:16 Circular 2017/02/22 Reinforced Co 102.4 FT</p>

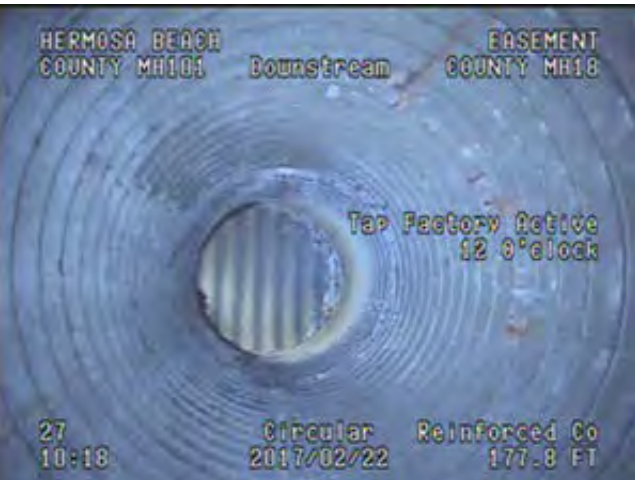
<p>HERMOSA BEACH COUNTY MH101 Downstream EASEMENT COUNTY MH18</p> <p style="text-align: right;">Tap Factory Active 12 o'clock</p> <p>27 10:18 Circular 2017/02/22 Reinforced Co 177.8 FT</p>

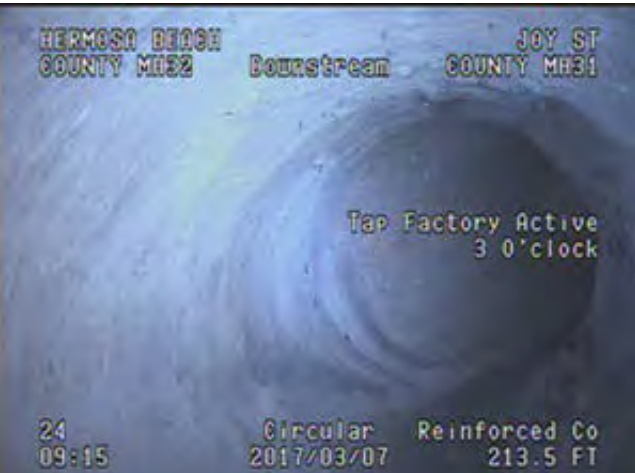
<p>HERMOSA BEACH COUNTY MH32      Downstream      JOY ST COUNTY MH31</p> <p style="text-align: right;">Tap Factory Active 3 0'clock</p> <p>24      Circular      Reinforced Co 09:15      2017/03/07      213.5 FT</p>

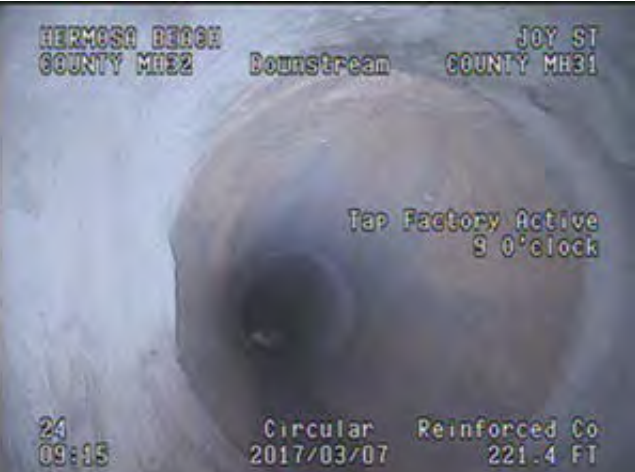
<p>HERMOSA BEACH COUNTY MH32      Downstream      JOY ST COUNTY MH31</p> <p style="text-align: right;">Tap Factory Active 9 0'clock</p> <p>24      Circular      Reinforced Co 09:15      2017/03/07      221.4 FT</p>

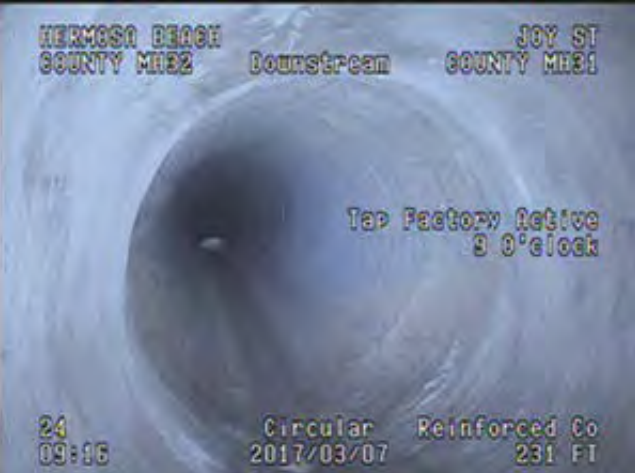
<p>HERMOSA BEACH COUNTY MH32      Downstream      JOY ST COUNTY MH31</p> <p style="text-align: right;">Tap Factory Active 9 0'clock</p> <p>24      Circular      Reinforced Co 09:16      2017/03/07      231 FT</p>

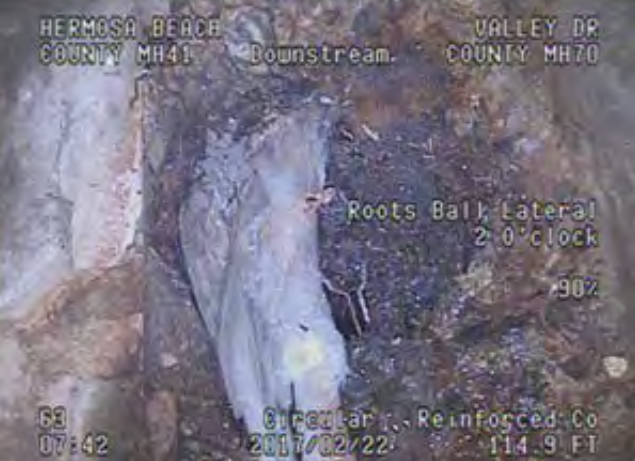
Distance	Fault Observation	Picture
114.9	<p>Roots Ball Lateral            Position: 2            Severity: None</p>

114.9	<p>Picture Number: 2            Roots Ball Lateral            Position: 2</p>	 
243.3	<p>Tap Factory Active            Position: 2            Severity: None            Size: 4</p>

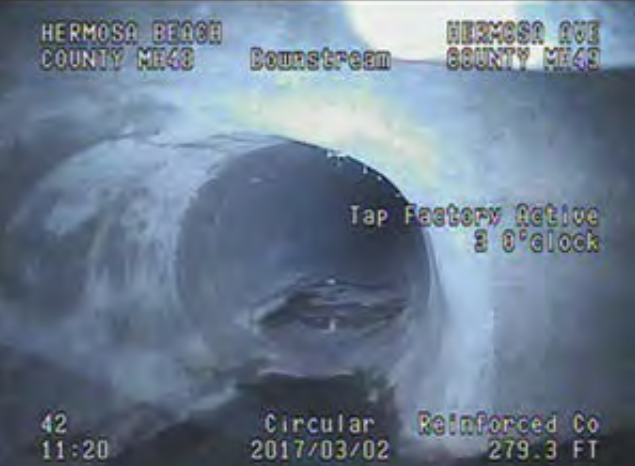
<p>HERMOSA BEACH COUNTY ME48      Bounstream      HERMOSA AVE COUNTY ME49</p> <p>Tap Factory Active 3 o'clock</p> <p>42      Circular      Reinforced Co 11:20      2017/03/02      279.3 FT</p>

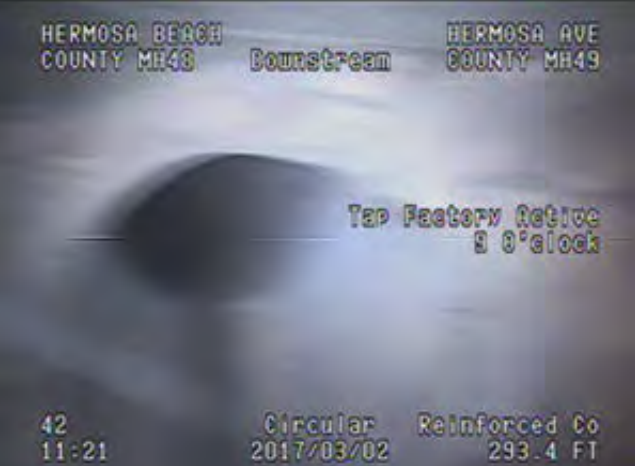
<p>HERMOSA BEACH COUNTY ME48      Bounstream      HERMOSA AVE COUNTY ME49</p> <p>Tap Factory Active 9 o'clock</p> <p>42      Circular      Reinforced Co 11:21      2017/03/02      293.4 FT</p>

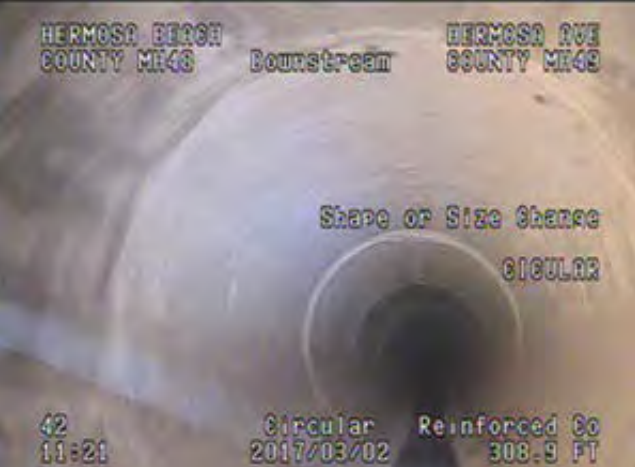
<p>HERMOSA BEACH COUNTY ME48      Bounstream      HERMOSA AVE COUNTY ME49</p> <p>Shape or Size Change CICULAR</p> <p>42      Circular      Reinforced Co 11:21      2017/03/02      308.9 FT</p>

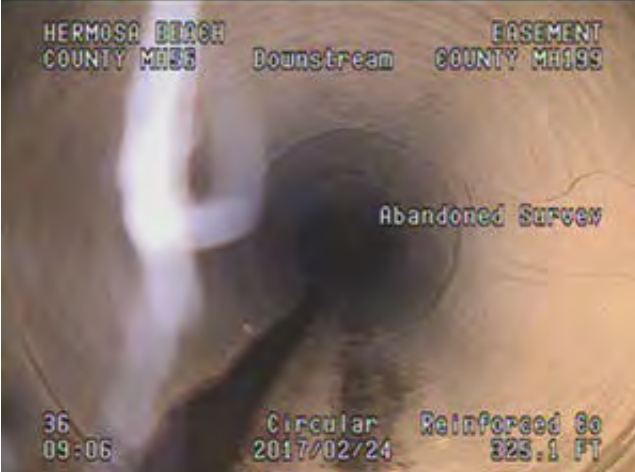
Distance	Fault Observation	Picture
325.1	<p style="text-align: center;"><b>Abandoned Survey</b>  <b>Severity: None</b>  <b>Remarks: WILL ATTEMPT A REV</b>  <b>PULL APROX 50FT FROM MH</b></p>

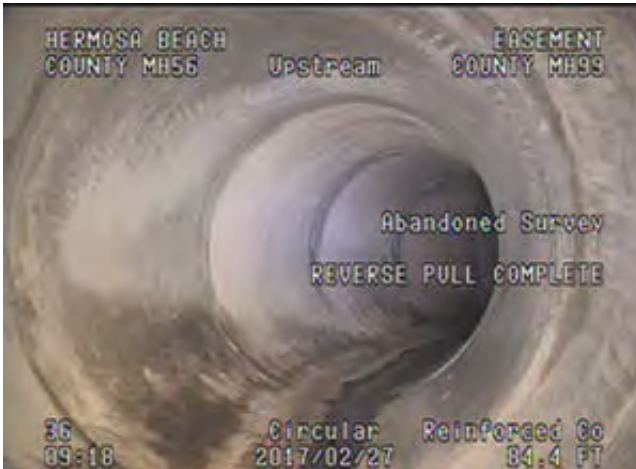
<p>HERMOSA BEACH COUNTY MH56 Upstream EASEMENT COUNTY MH99 Water Level 36 09:15 Circular 2017/02/27 Reinforced Co 0 FT</p>
84.4	<p align="center"><b>Abandoned Survey</b> Severity: None Remarks: REVERSE PULL COMPLETE</p>

<p>HERMOSA BEACH COUNTY MH56 Upstream EASEMENT COUNTY MH99 Abandoned Survey REVERSE PULL COMPLETE 36 09:18 Circular 2017/02/27 Reinforced Co 84.4 FT</p>

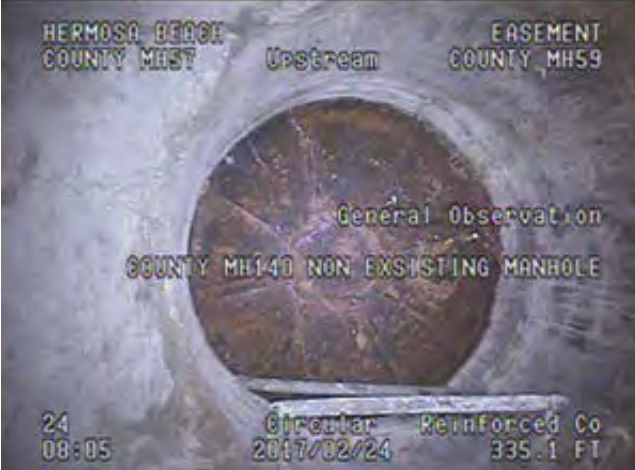
Distance	Fault Observation	Picture
335.1	<p align="center"> <b>General Observation</b>  <b>Severity: None</b>  <b>Remarks: COUNTY MH140 NON EXSISTING MANHOLE</b> </p>

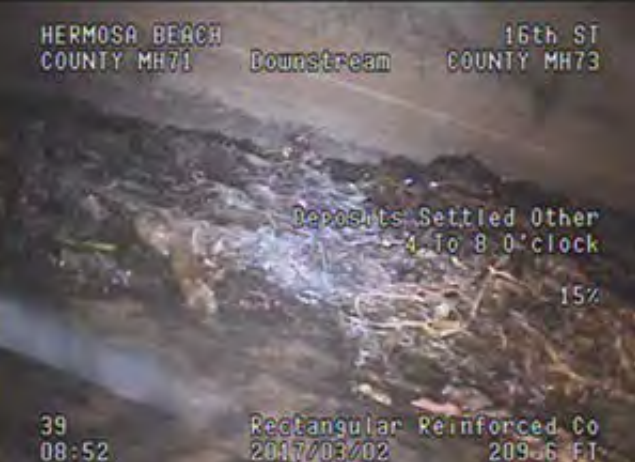
<p>HERMOSA BEACH COUNTY MH71 Downstream 16th ST COUNTY MH73</p> <p>Tap Factory Active 3 0'clock</p> <p>39 08:52 Rectangular Reinforced Co 2017/03/02 209.6 FT</p>
209.6	<p><b>Deposits Settled Other</b>  <b>Position: 4 To 8</b>  <b>Severity: None</b>  <b>Remarks:</b></p>

<p>HERMOSA BEACH COUNTY MH71 Downstream 16th ST COUNTY MH73</p> <p>Deposits Settled Other 4 To 8 0'clock</p> <p>15%</p> <p>39 08:52 Rectangular Reinforced Co 2017/03/02 209.6 FT</p>

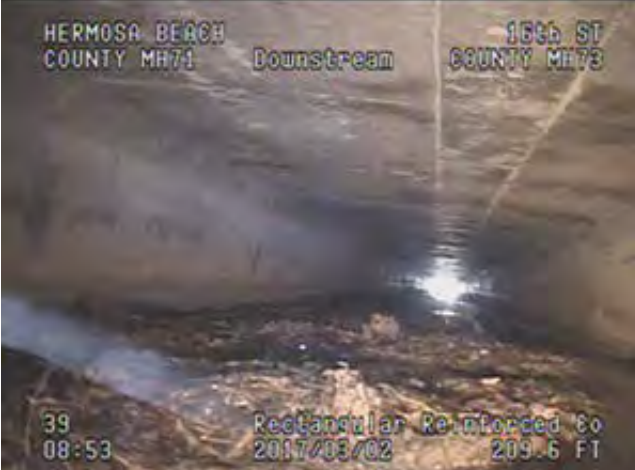
Distance	Fault Observation	Picture
209.6	<p>Picture Number: 2  Deposits Settled Other  Position: 4 To 8</p>

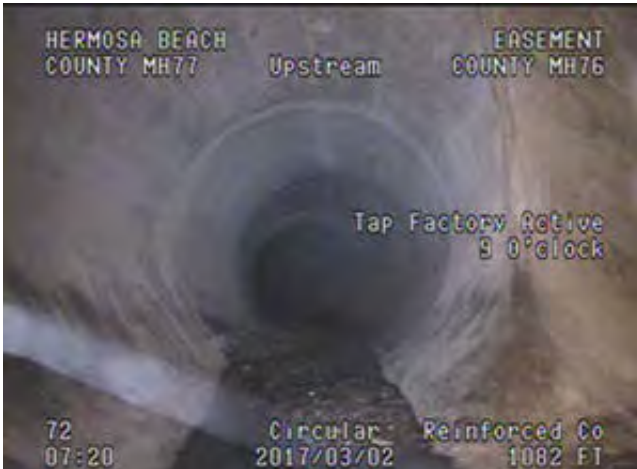
1,082.0	<p align="center"><b>Tap Factory Active</b>  <b>Position: 9</b>  <b>Severity: None</b>  <b>Size: 60</b></p>

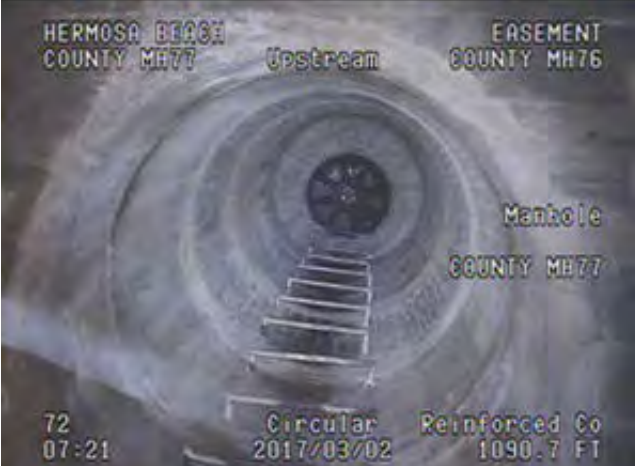
Distance	Fault Observation	Picture
1,090.6	<p style="text-align: center;"> <b>Manhole</b>  <b>Severity: None</b>  <b>Remarks: COUNTY MH77</b> </p>

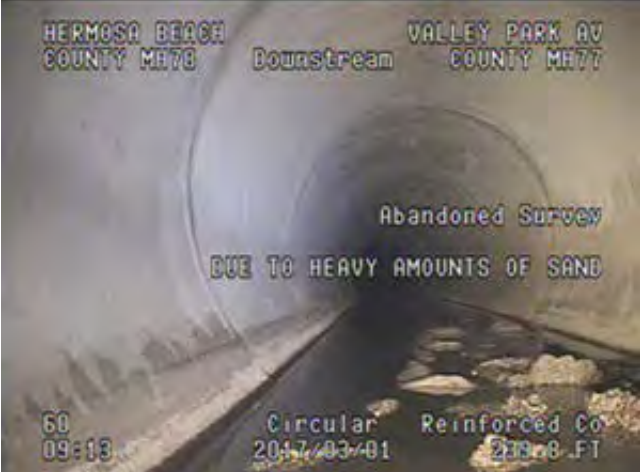
Distance	Fault Observation	Picture
239.8	<p style="text-align: center;">Abandoned Survey Severity: None Remarks: DUE TO HEAVY AMOUNTS OF SAND</p>

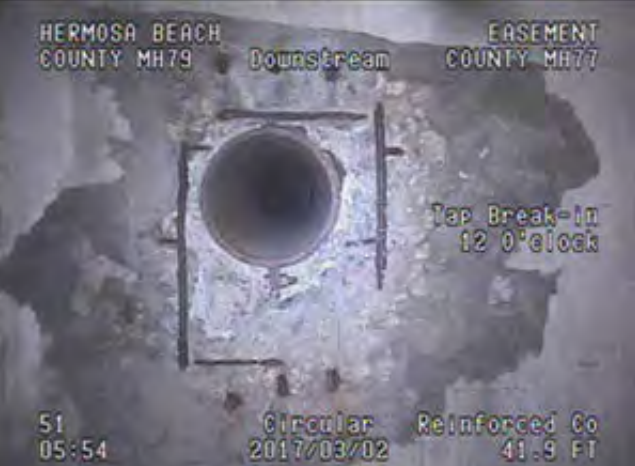
Distance	Fault Observation	Picture
41.9	<p style="text-align: center;"> <b>Tap Break-in</b>  <b>Position: 12</b>  <b>Severity: None</b>  <b>Size: 8</b> </p>

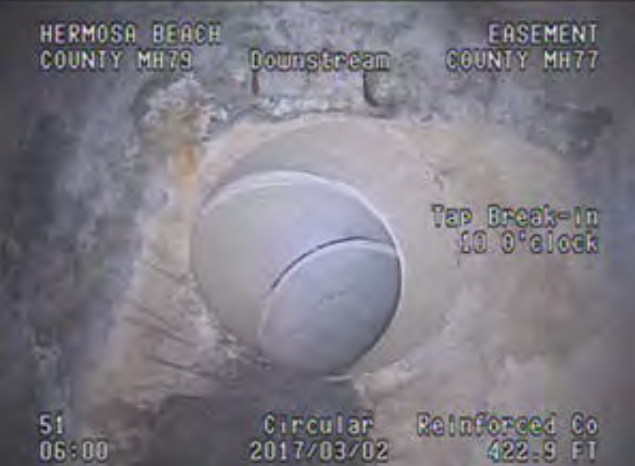
<p>HERMOSA BEACH COUNTY MH79 Downstream EASEMENT COUNTY MH77</p> <p>Tap Break-in 12 O'clock</p> <p>51 05:54 Circular 2017/03/02 Reinforced Co 41.9 FT</p>
422.9	<p style="text-align: center;"> <b>Tap Break-in</b>  <b>Position: 10</b>  <b>Severity: None</b>  <b>Size: 8</b> </p>

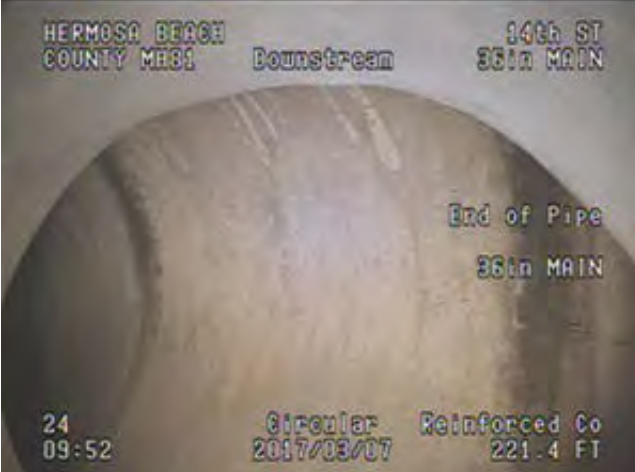
Distance	Fault Observation	Picture
221.4	<p style="text-align: center;"> <b>End of Pipe</b>  <b>Severity: None</b>  <b>Remarks: 36in MAIN</b> </p>

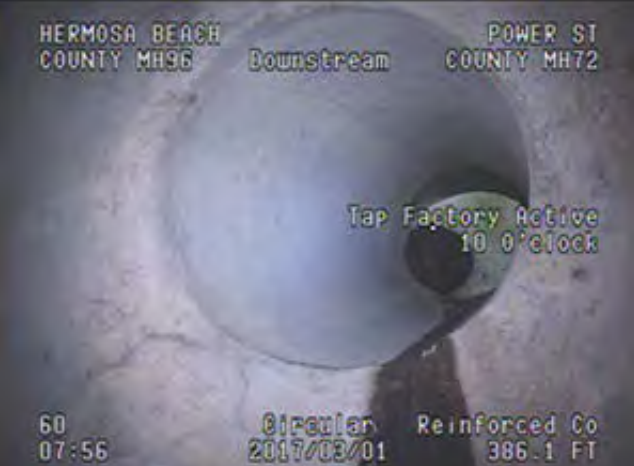
386.1	<p><b>Tap Factory Active</b>  <b>Position: 10</b>  <b>Severity: None</b>  <b>Size: 18</b></p>

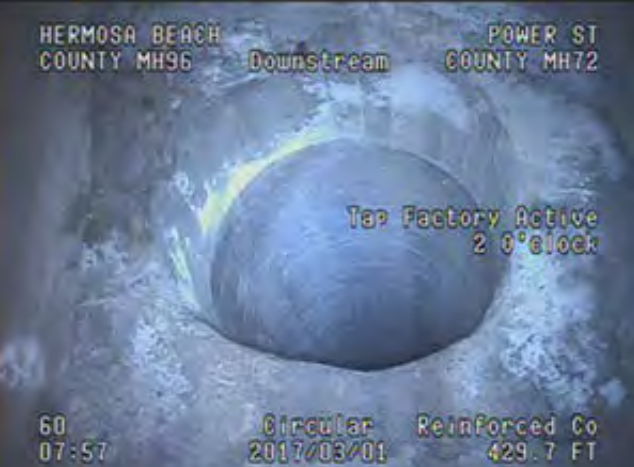
429.7	<p><b>Tap Factory Active</b>  <b>Position: 2</b>  <b>Severity: None</b>  <b>Size: 18</b></p>

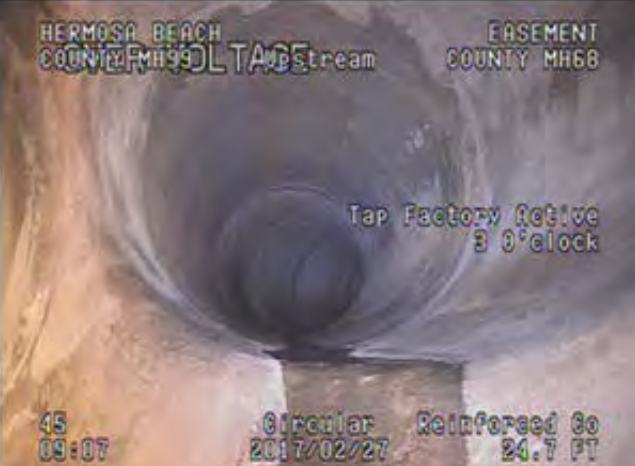
Distance	Fault Observation	Picture
24.7	<p style="text-align: center;"> <b>Tap Factory Active</b>  <b>Position: 3</b>  <b>Severity: None</b>  <b>Size: 30</b> </p>

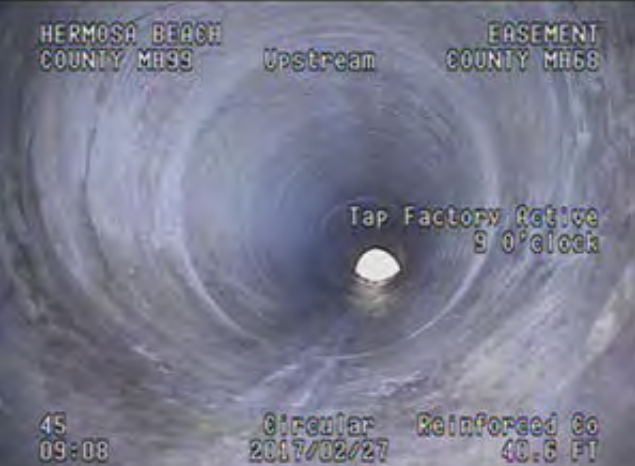
40.6	<p style="text-align: center;"> <b>Tap Factory Active</b>  <b>Position: 9</b>  <b>Severity: None</b>  <b>Size: 18</b> </p>

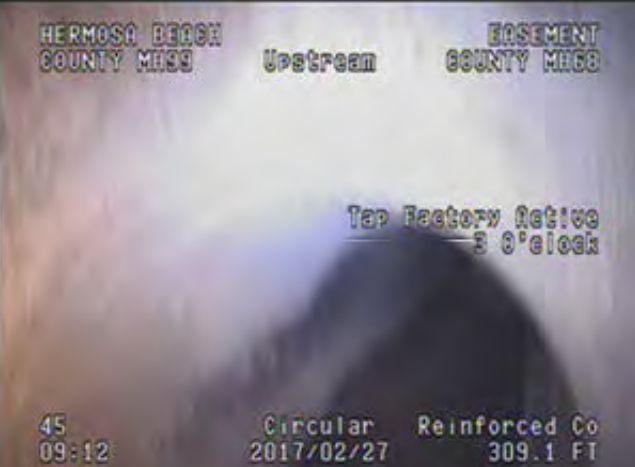
309.1	<p style="text-align: center;"> <b>Tap Factory Active</b>  <b>Position: 3</b>  <b>Severity: None</b>  <b>Size: 18</b> </p>

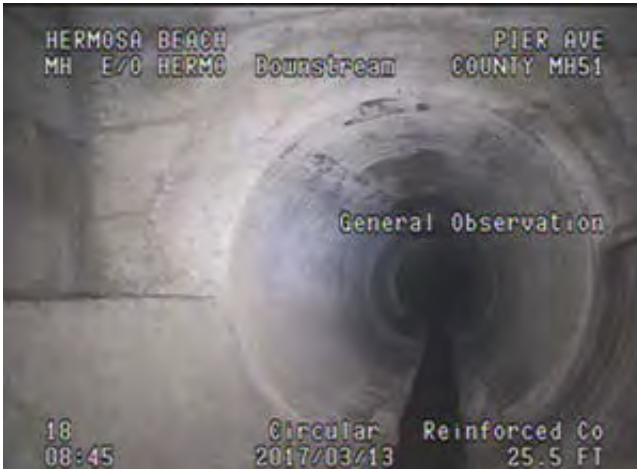
25.5	<p align="center"><b>General Observation</b> Severity: None Remarks: MANHOLE EAST OF HERMOSA AVE (COUNTY IN 95)</p>

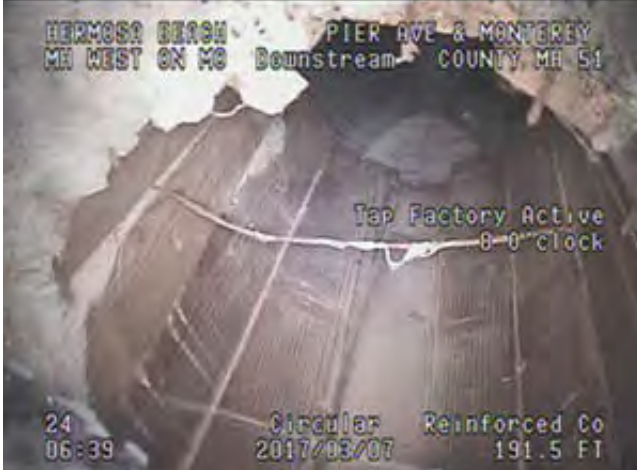
Distance	Fault Observation	Picture
191.5	<p style="text-align: center;"><b>Tap Factory Active</b>  <b>Position: 8</b>  <b>Severity: None</b>  <b>Size: 18</b></p>

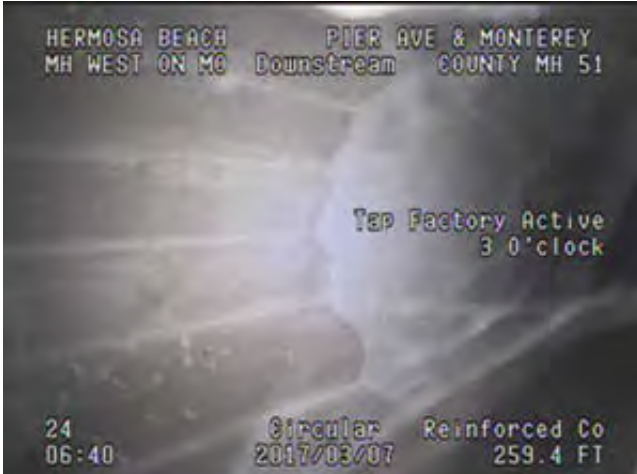
259.4	<p style="text-align: center;"><b>Tap Factory Active</b>  <b>Position: 3</b>  <b>Severity: None</b>  <b>Size: 18</b></p>

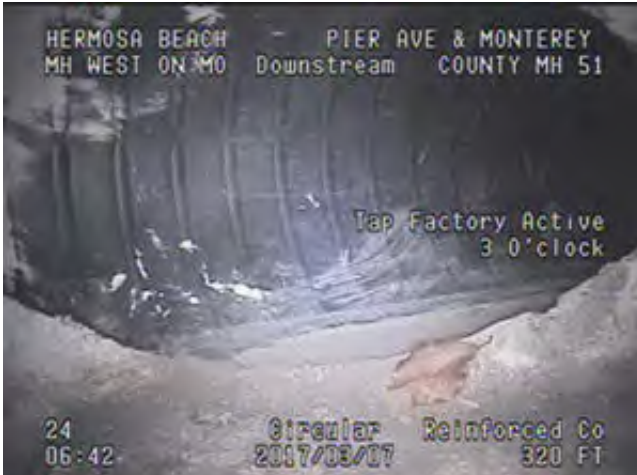
320.0	<p style="text-align: center;"><b>Tap Factory Active</b>  <b>Position: 3</b>  <b>Severity: None</b>  <b>Size: 18</b></p>

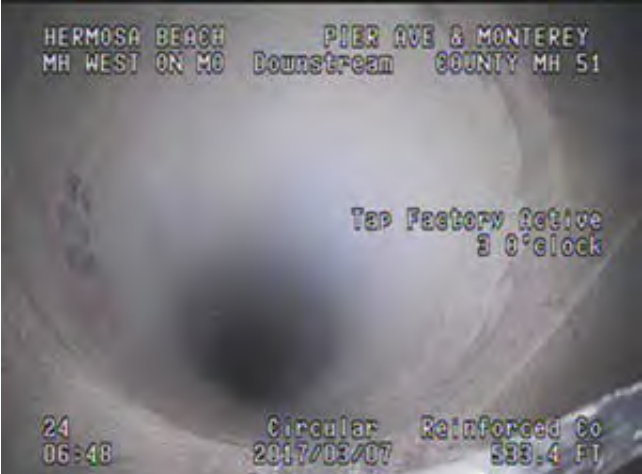
Distance	Fault Observation	Picture
533.4	<p style="text-align: center;"> <b>Tap Factory Active</b>  <b>Position: 3</b>  <b>Severity: None</b>  <b>Size: 18</b> </p>

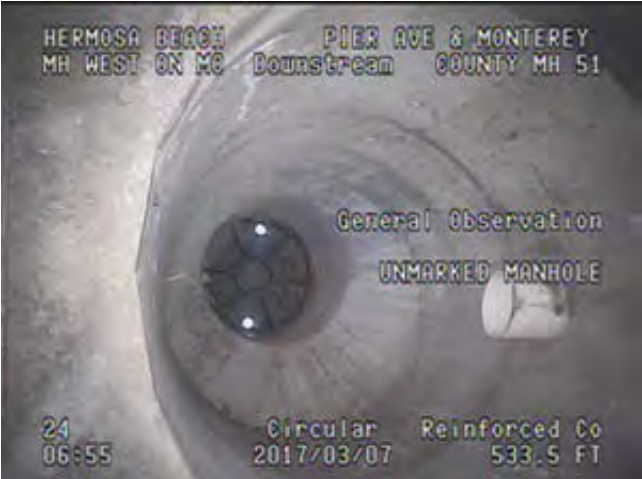
533.5	<p style="text-align: center;"> <b>General Observation</b>  <b>Severity: None</b>  <b>Remarks: UNMARKED MANHOLE</b> </p>

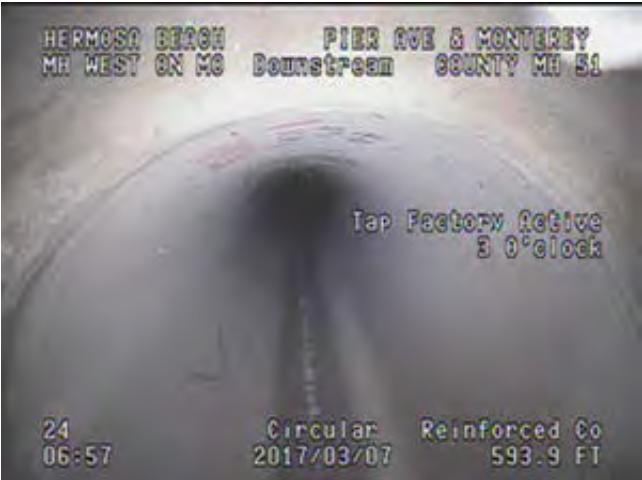
593.9	<p style="text-align: center;"> <b>Tap Factory Active</b>  <b>Position: 3</b>  <b>Severity: None</b>  <b>Size: 18</b> </p>

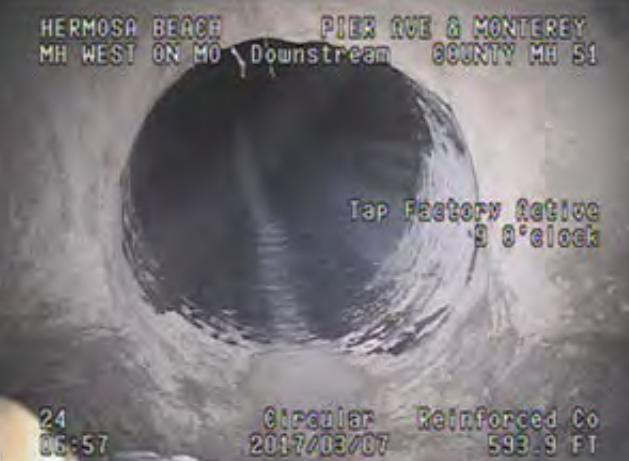
<p>HERMOSA BEACH PIER AVE &amp; MONTEREY  MH WEST ON MO Downstream COUNTY MH 51</p> <p>Tap Factory Active  9 o'clock</p> <p>24 Circular Reinforced Co  06:57 2017/03/07 593.9 FT</p>

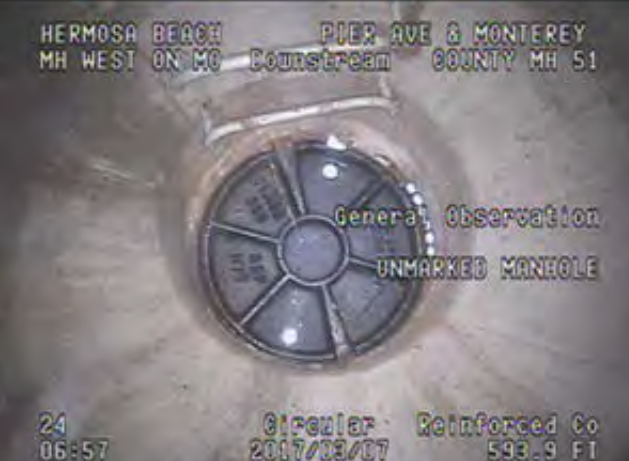
<p>HERMOSA BEACH PIER AVE &amp; MONTEREY  MH WEST ON MO Downstream COUNTY MH 51</p> <p>General Observation  UNMARKED MANHOLE</p> <p>24 Circular Reinforced Co  06:57 2017/03/07 593.9 FT</p>

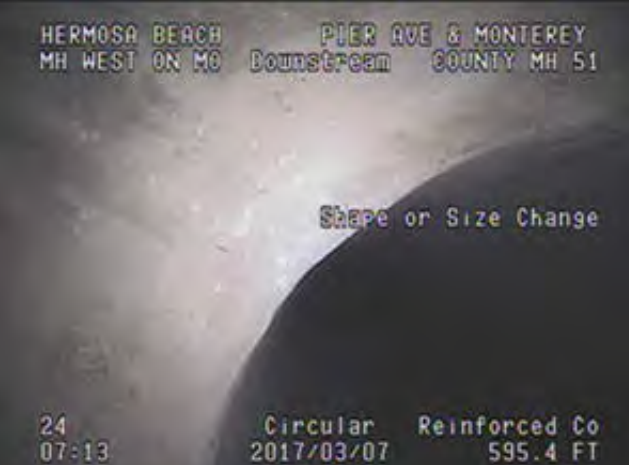
<p>HERMOSA BEACH PIER AVE &amp; MONTEREY  MH WEST ON MO Downstream COUNTY MH 51</p> <p>Shape or Size Change</p> <p>24 Circular Reinforced Co  07:13 2017/03/07 595.4 FT</p>

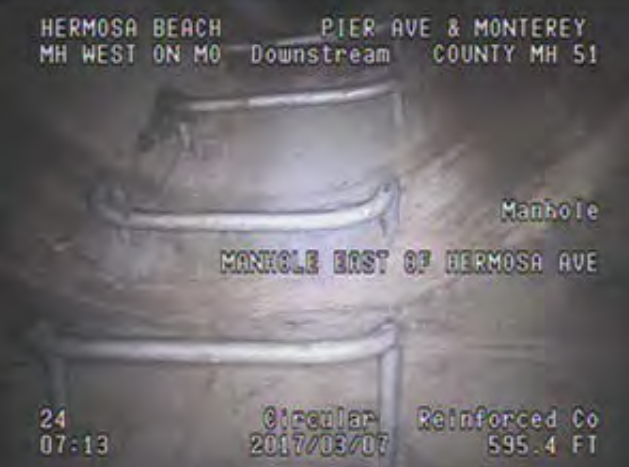
Distance	Fault Observation	Picture
595.4	<p align="center"> <b>Manhole</b>  <b>Severity: None</b>  <b>Remarks: MANHOLE EAST OF</b>  <b>HERMOSA AVE</b> </p>
