Sewer Master Plan

August 2017

Prepared for
City of Hermosa Beach
1315 Valley Drive
Hermosa Beach, CA 90254

Prepared by
David Evans and Associates, Inc.
17782 17th Street, Suite 200
Tustin, CA 92780

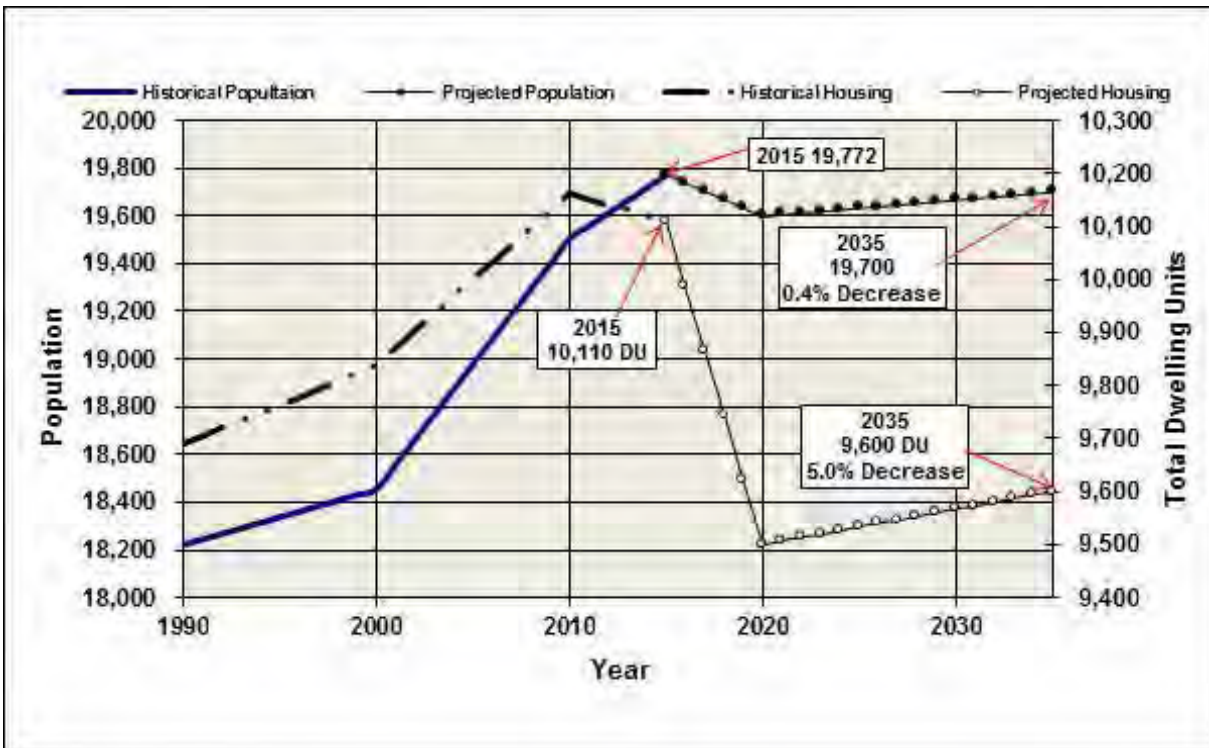
Figure 1-4 Historical and Projected Population and Housing

As shown in Table 1-4 and on Figure 1-4, the City's population is relatively constant with very slow growth. The SCAG data indicates that Hermosa Beach's population is projected to decrease to 19,600 by the year 2020 but return to a trend of slow growth through 2035. Housing is also projected to decrease by 1.24 percent (relative to 2015) to 9,500 dwelling units in 2020. This projected estimate seems low considering that the City's available housing has not been that low since before 1990. Based on past trends, it is reasonable to assume that available housing will remain roughly constant in the near future at around 10,100 dwelling units. Assuming that vacancy will remain at 6.00 percent, the City's population density would remain constant at 2.19 people per occupied dwelling unit through the year 2035.

Historical population and housing data was obtained from the California Department of Finance. As shown in Table 1-4 and on Figure 1-4, the City's population increased from 18,219 in 1990 to 18,453 in 2000, which was an average annual increase of 0.13 percent. The population increased further by 0.56 percent annually between 2000 and 2010. Since then, the City's population has been continuing a slow increase, and was 19,772 by January 2015.

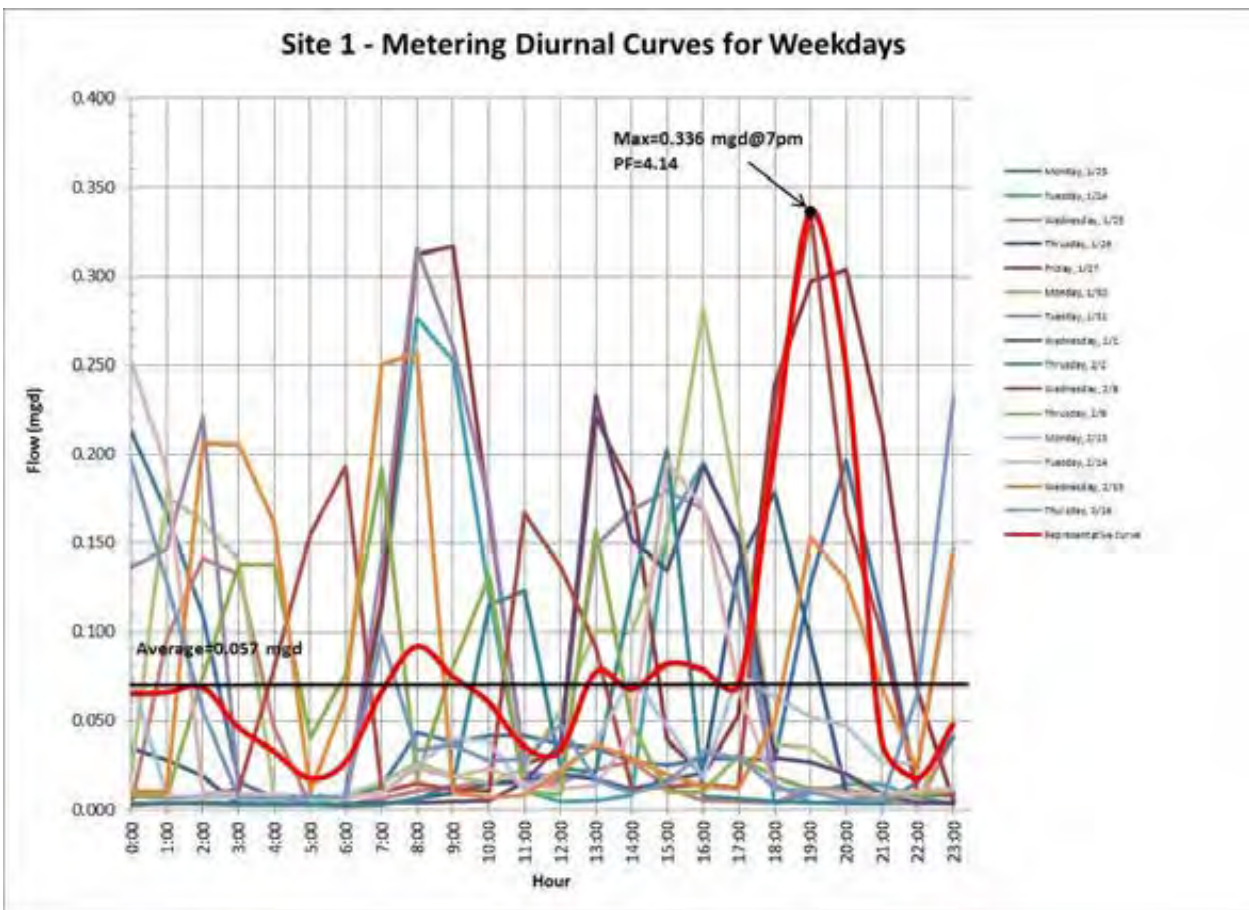
Figure 2-2: Metering and Representative Diurnal Curves for Site 1 (Weekday)

Flow data for Meter Basin No. 1 is shown in Figure 2-2. Meter Basin No. 1 is located in the northwest corner of the City. The basin is the smallest with only 4 acres of drainage area. This basin is primarily residential; however, just downstream of the monitored site is a pump station that moves discharge up from the beach area and into a pipe system that discharges to the county system. This pump system disrupts the dry weather pattern that is typical of a residential area as can be seen in Figure 2-2.

Lowest use at 5am

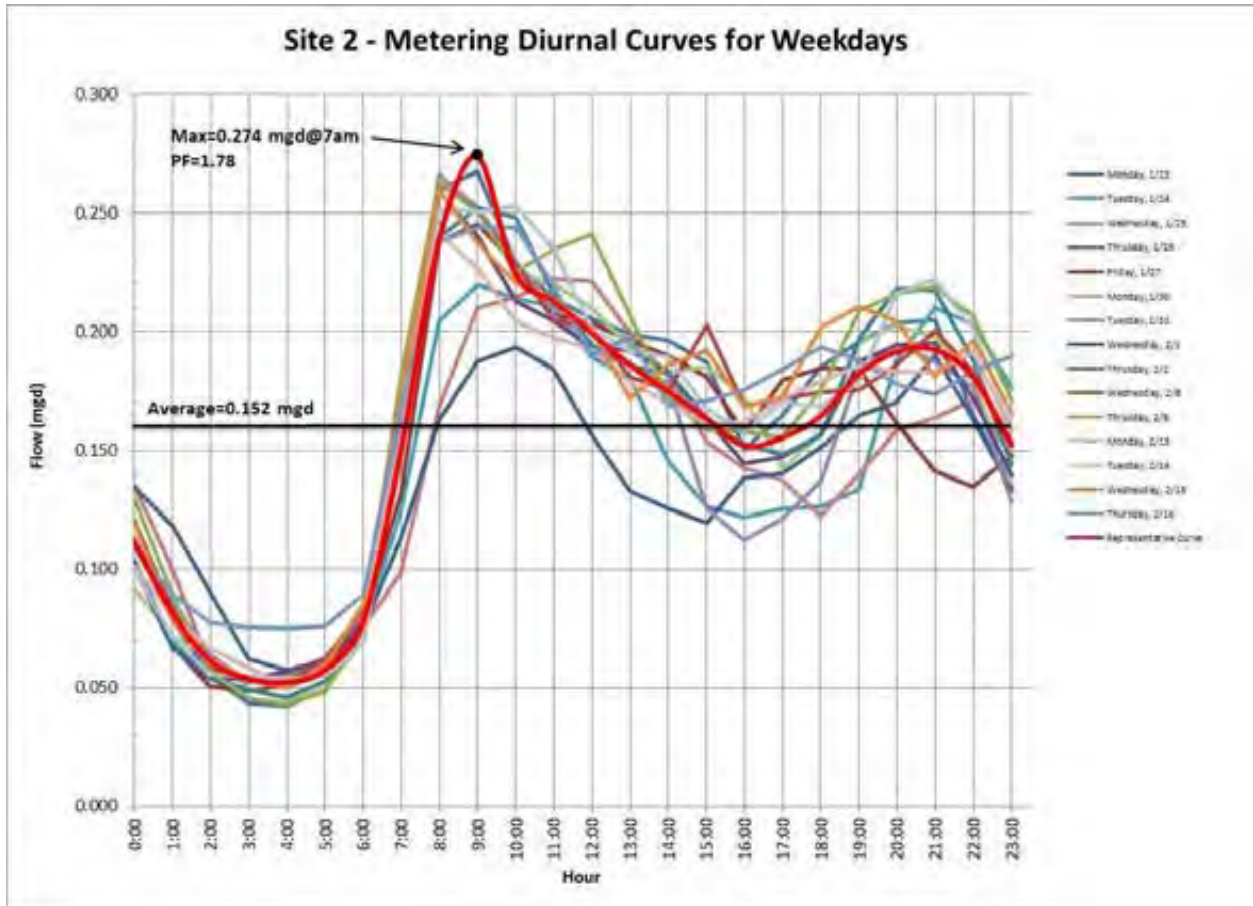
Figure 2-3 Metering and Representative Diurnal Curves for Site 2 (Weekday)

Flow data for Meter Basin No. 2 are shown in Figure 2-3. Meter Basin No. 2 is located in the north area of the City. The basin totals nearly 98 acres of drainage area with the majority serving residential areas.

Lowest use at 4am

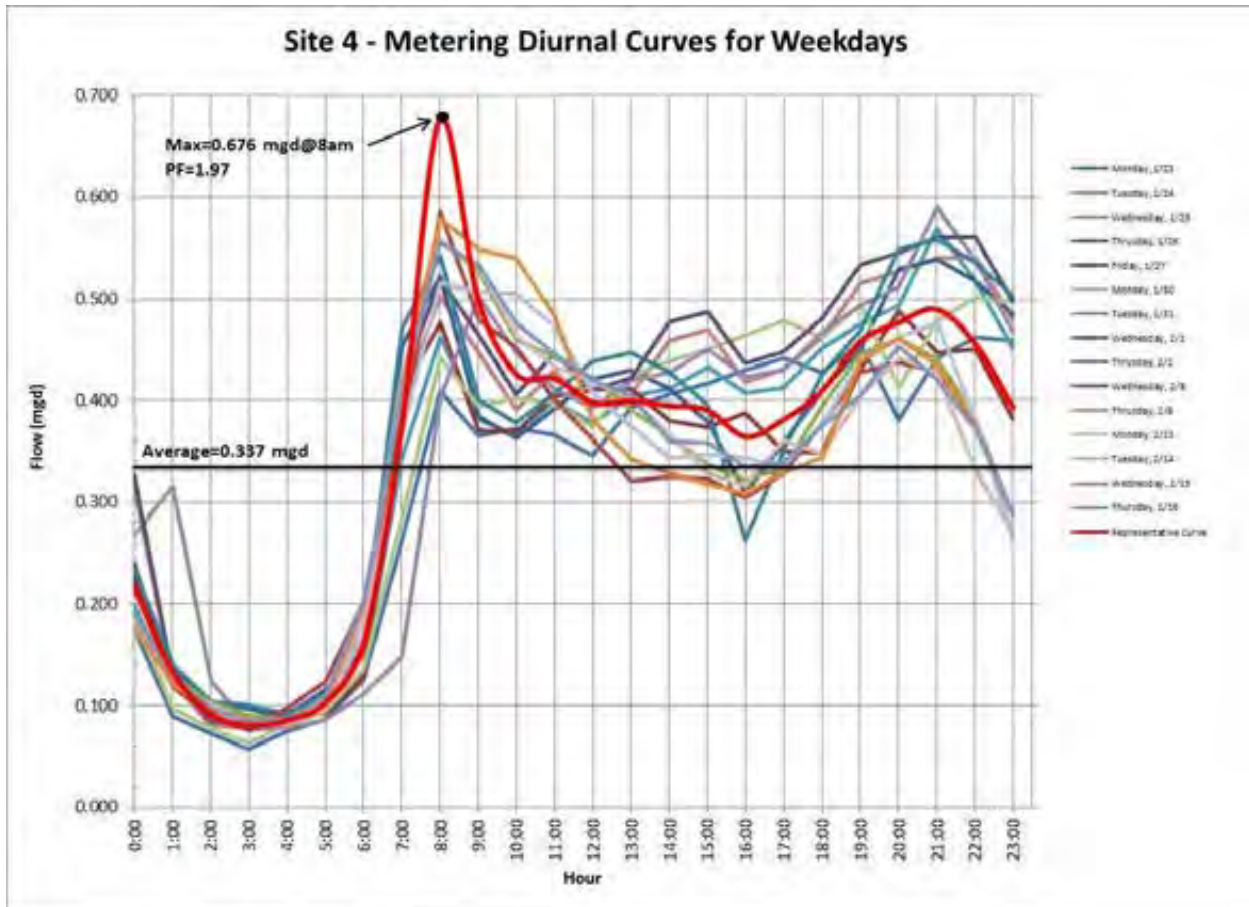
Figure 2-5: Metering and Representative Diurnal Curves for Site 4 (Weekday)

Flow data for Meter Basin No. 4 is shown in Figure 2-5. Meter Basin No. 4 is located in the center area of the city and is a sub-basin to Basin No. 3 covering 237 acres. The basin contains a mix of residential and commercial uses.

Lowest use at 3am

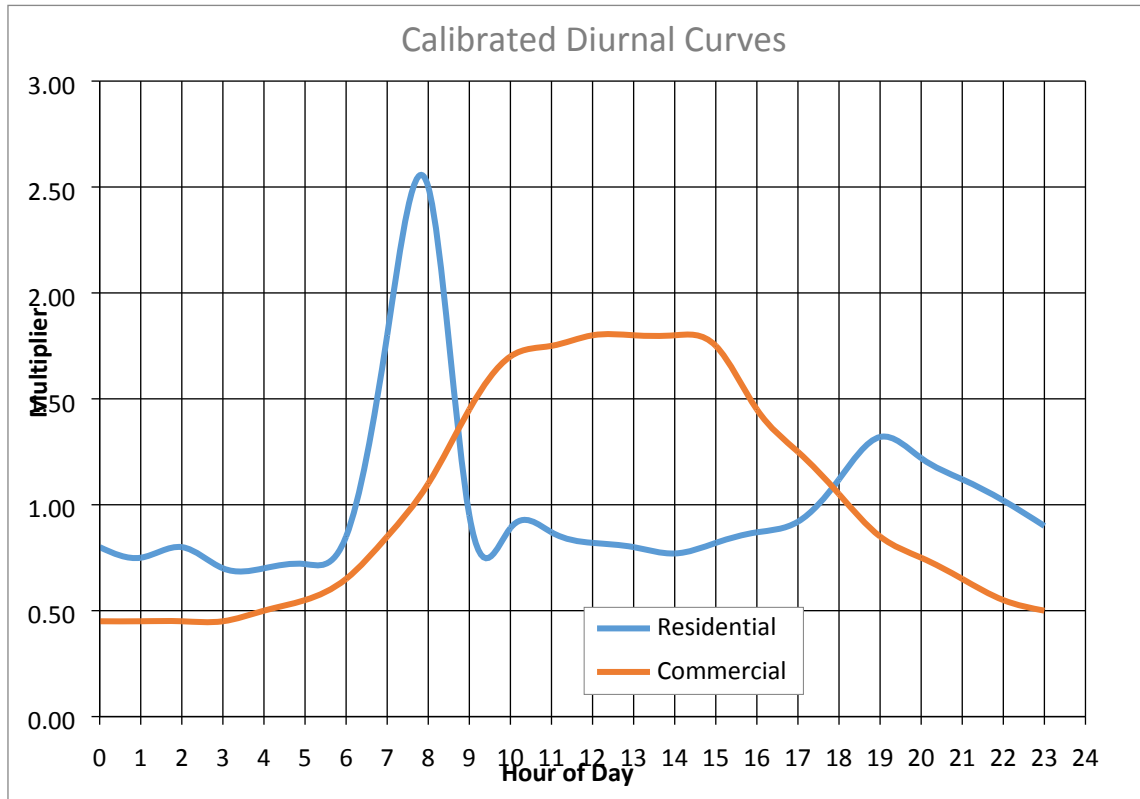
Figure 3-1: Calibrated Diurnal Curves

After the hydraulic model was built in InfoSewer, model calibration was performed to ensure the hydraulic model is producing similar hydrographs at the seven temporary metering sites. Figure 3-1 shows the diurnal curves that were calibrated and used in the InfoSewer model.

The residential curve is primarily extracted from the measured flow data at meter site No. 5 with an adjusted and higher peaking factor of 2.5 at about 8 am to account for flow attenuation effect that was embedded in the measured flow data. The commercial curve was initially developed from the metering data for other projects and was adjusted primarily with data from Sites 4, 5 and 6, which have commercial elements within each basin. The peaking factor for the commercial curve is 1.8 occurring at about 1 pm.

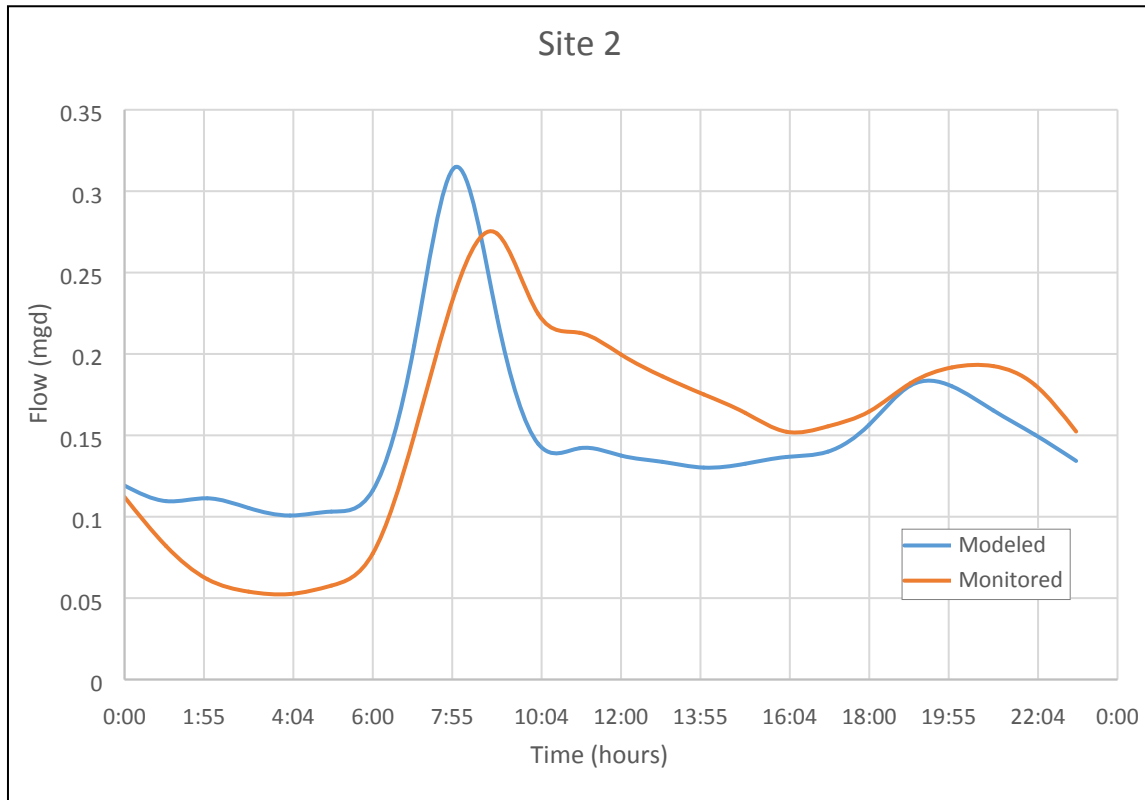
Figure 3-2: Model Calibration Results (Site 2)

Site 1 was disregarded for calibration because it is influenced by the pump station just downstream of the data collection site and therefore does not represent diurnal patterns for that basin. Site 3 data was collected just downstream of Site 4 and therefore disregarded as being redundant with Site 4. Table 3-3 summarizes the calibration results. Figures 3-2 through 3-6 show the comparison of the model results and the field measurement for each site graphically.

In general, the calibrated model was able to predict average flow and peak flow at the five outfalls near or within 15 percent with the exception of Site 7. Site 7 shows an exaggerated peak that will provide conservative results for this area. The possible causes for the variances of the model results include uncertainty about invert elevations in the original GIS, instrument errors associated with the metering equipment and the underlying assumptions in the model software.

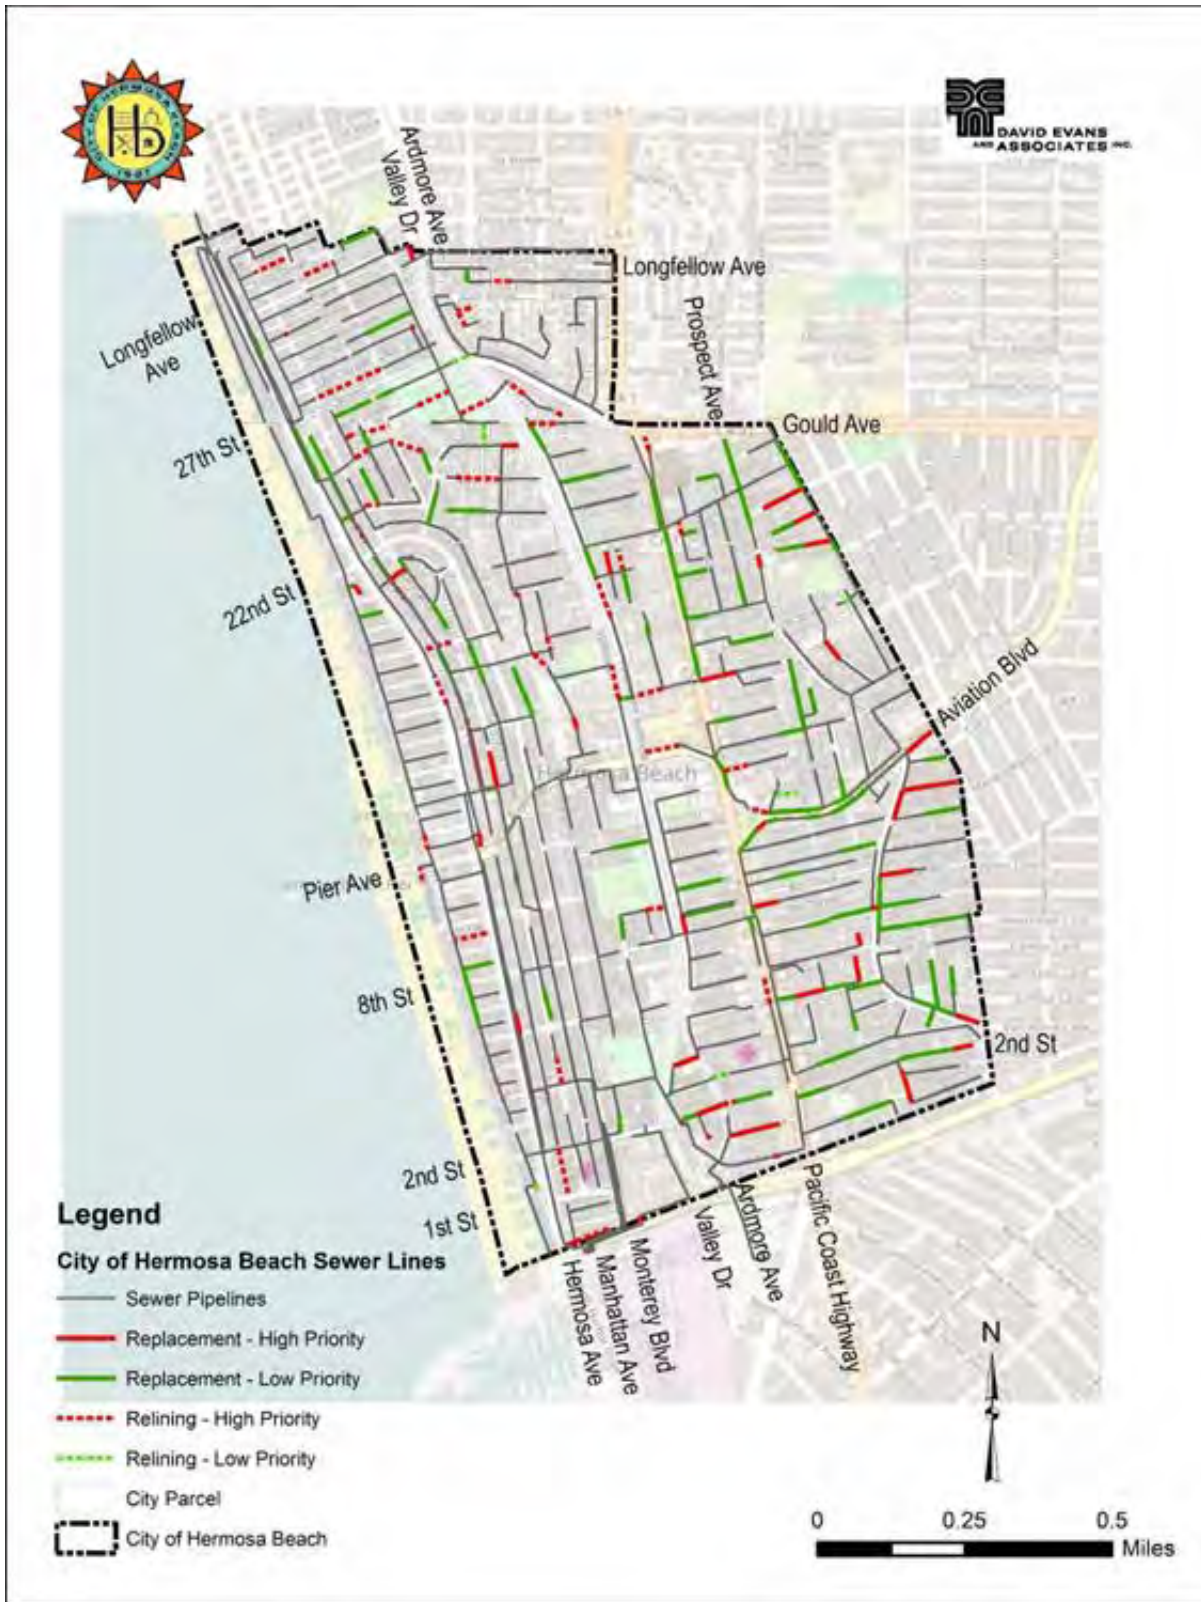
Figure 5-3: Sewer System Defects Recommended for Rehabilitation

Sewer segments recommended for rehabilitation or replacement within the 10-year CIP are shown on Figure 5-3 and are listed in Table 5-2. The defects to be repaired are associated with videotaped sewer segments totaling 222,000 linear feet (42 miles).

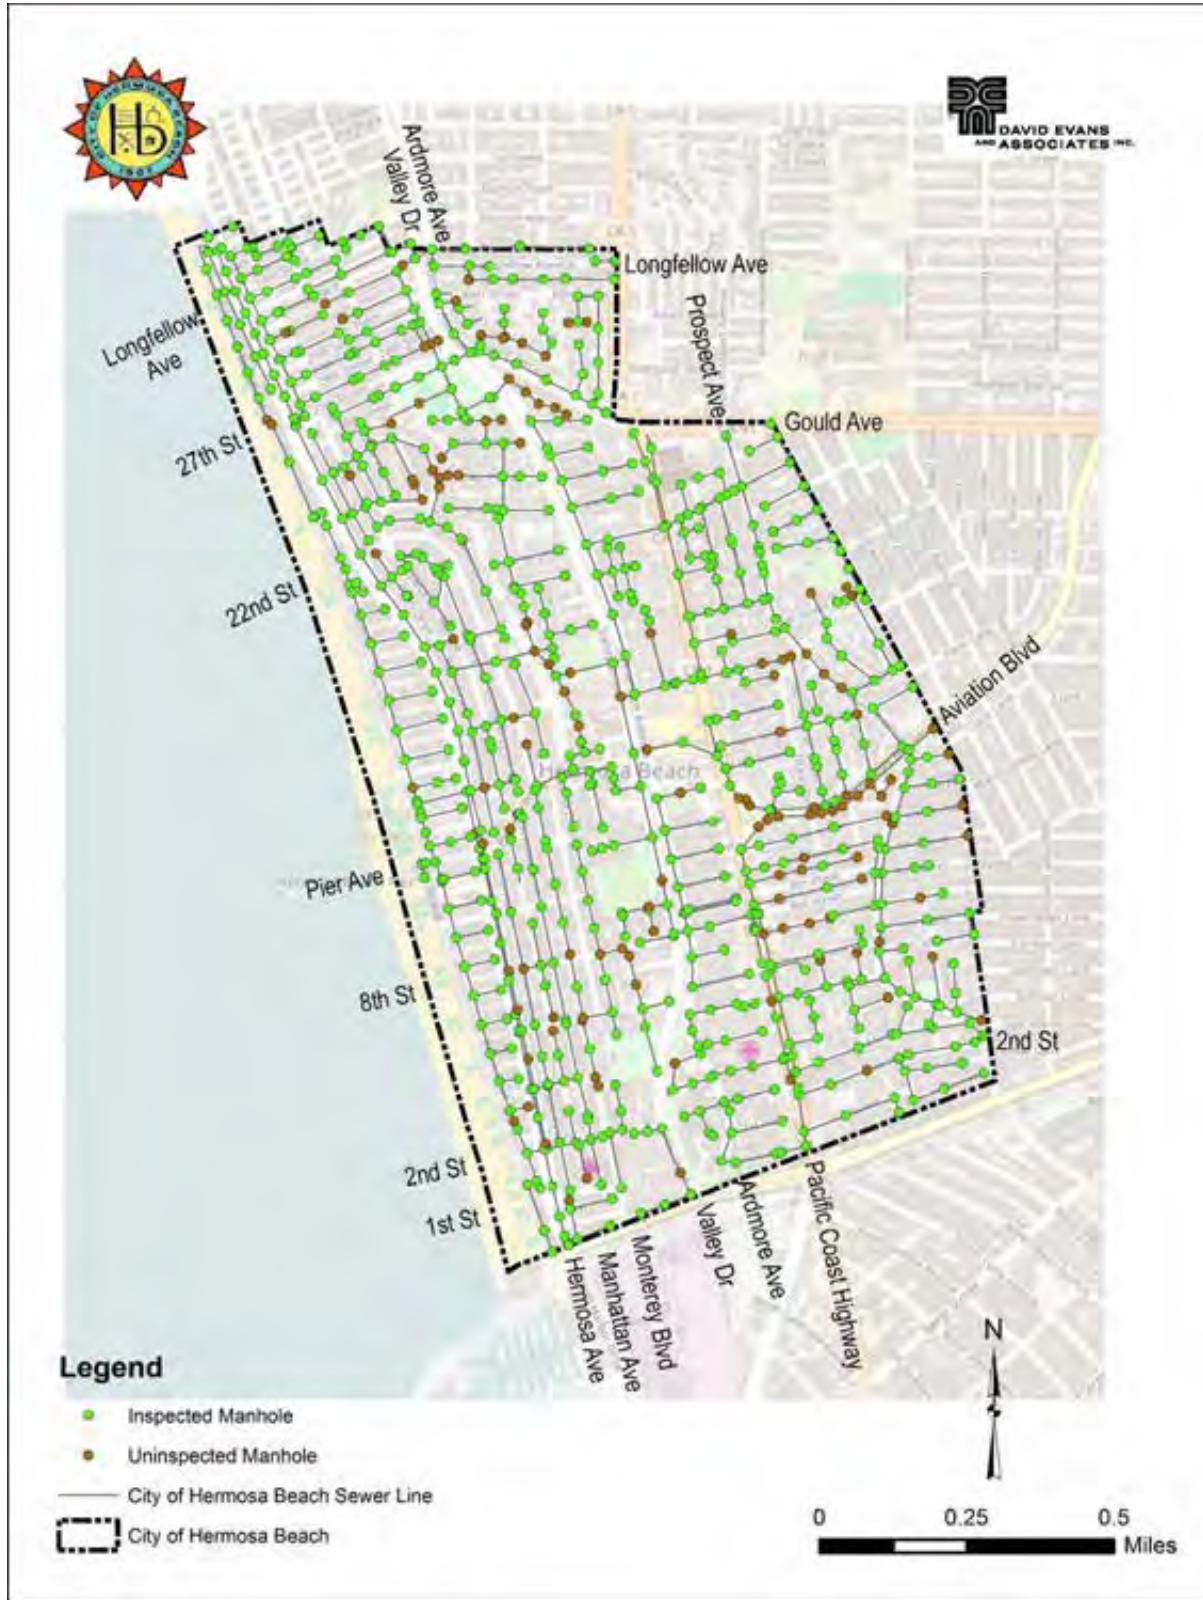
Figure 5-4: Inspected Manholes

Manhole inspections were performed to determine the condition of the key components of the manholes and to observe and document any defects. A total of 771 manholes were inspected for condition assessment. Figure 5-4 shows a map of the inspected manholes.

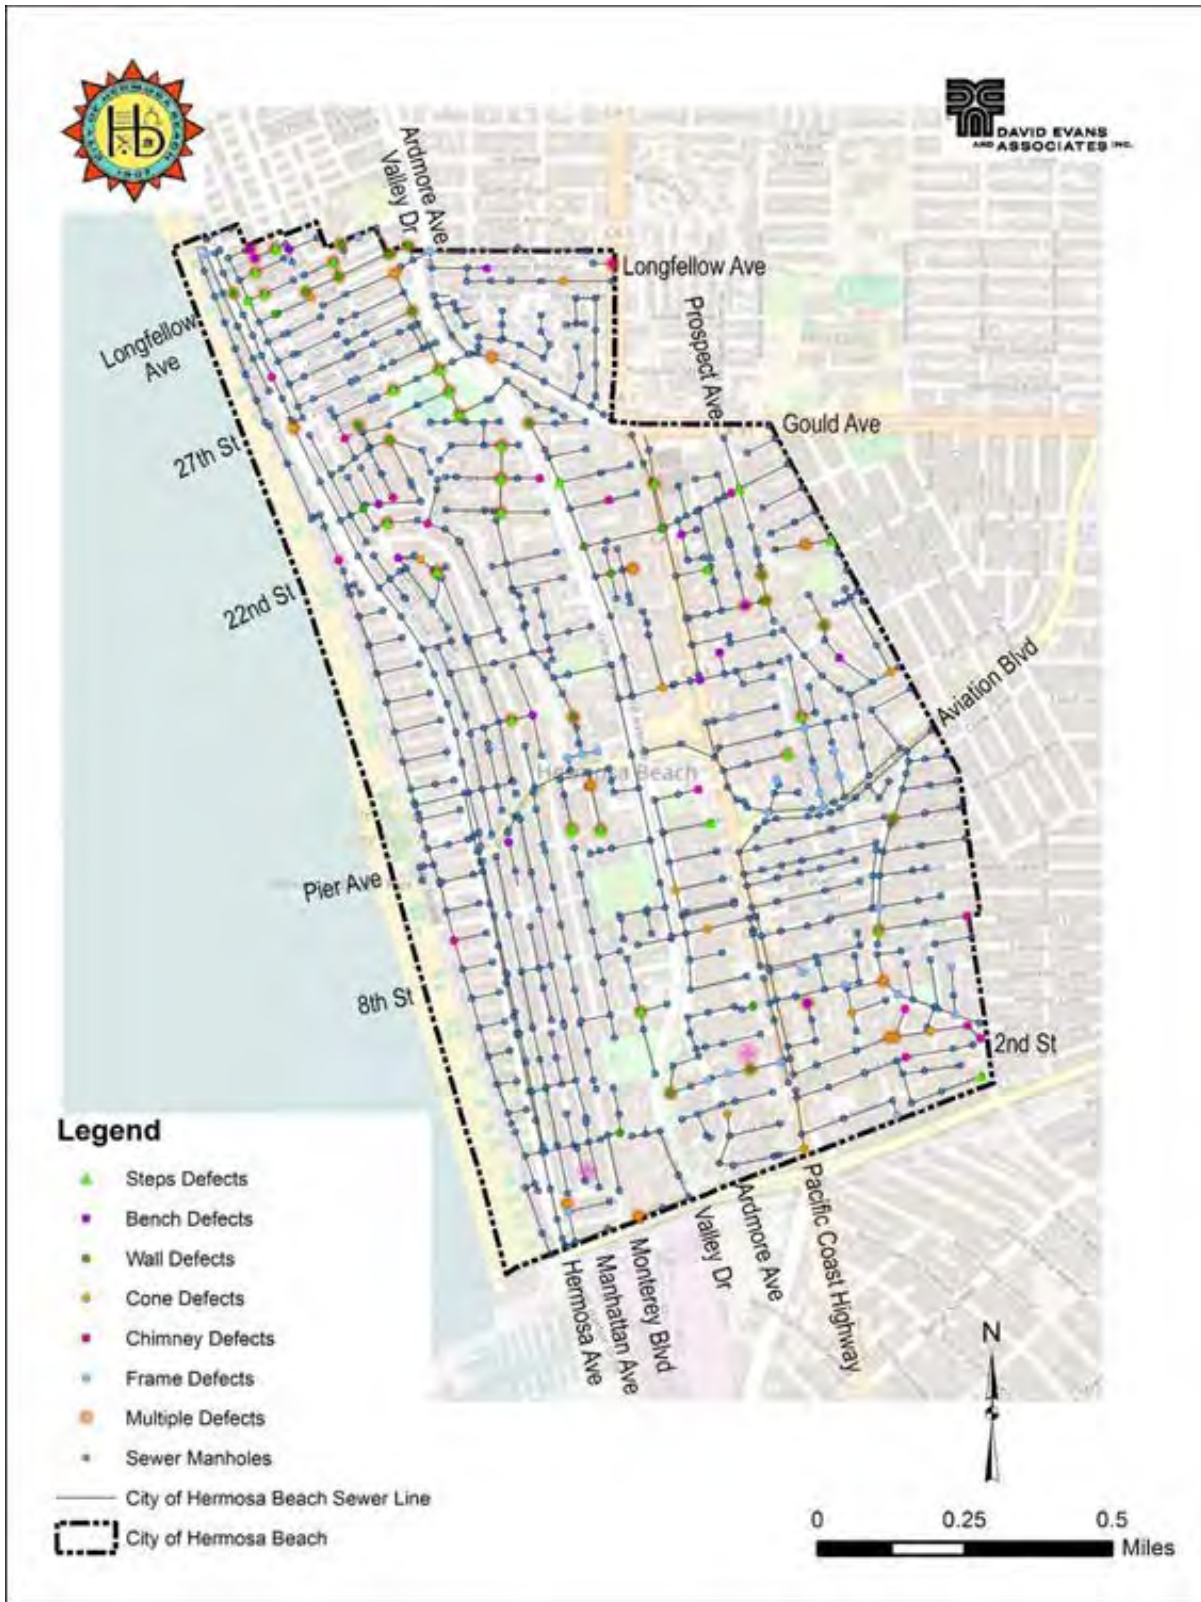
Figure 5-5: Manhole Defects

Figure 5-5 shows a color-coded map of manholes and grouping of their defects.

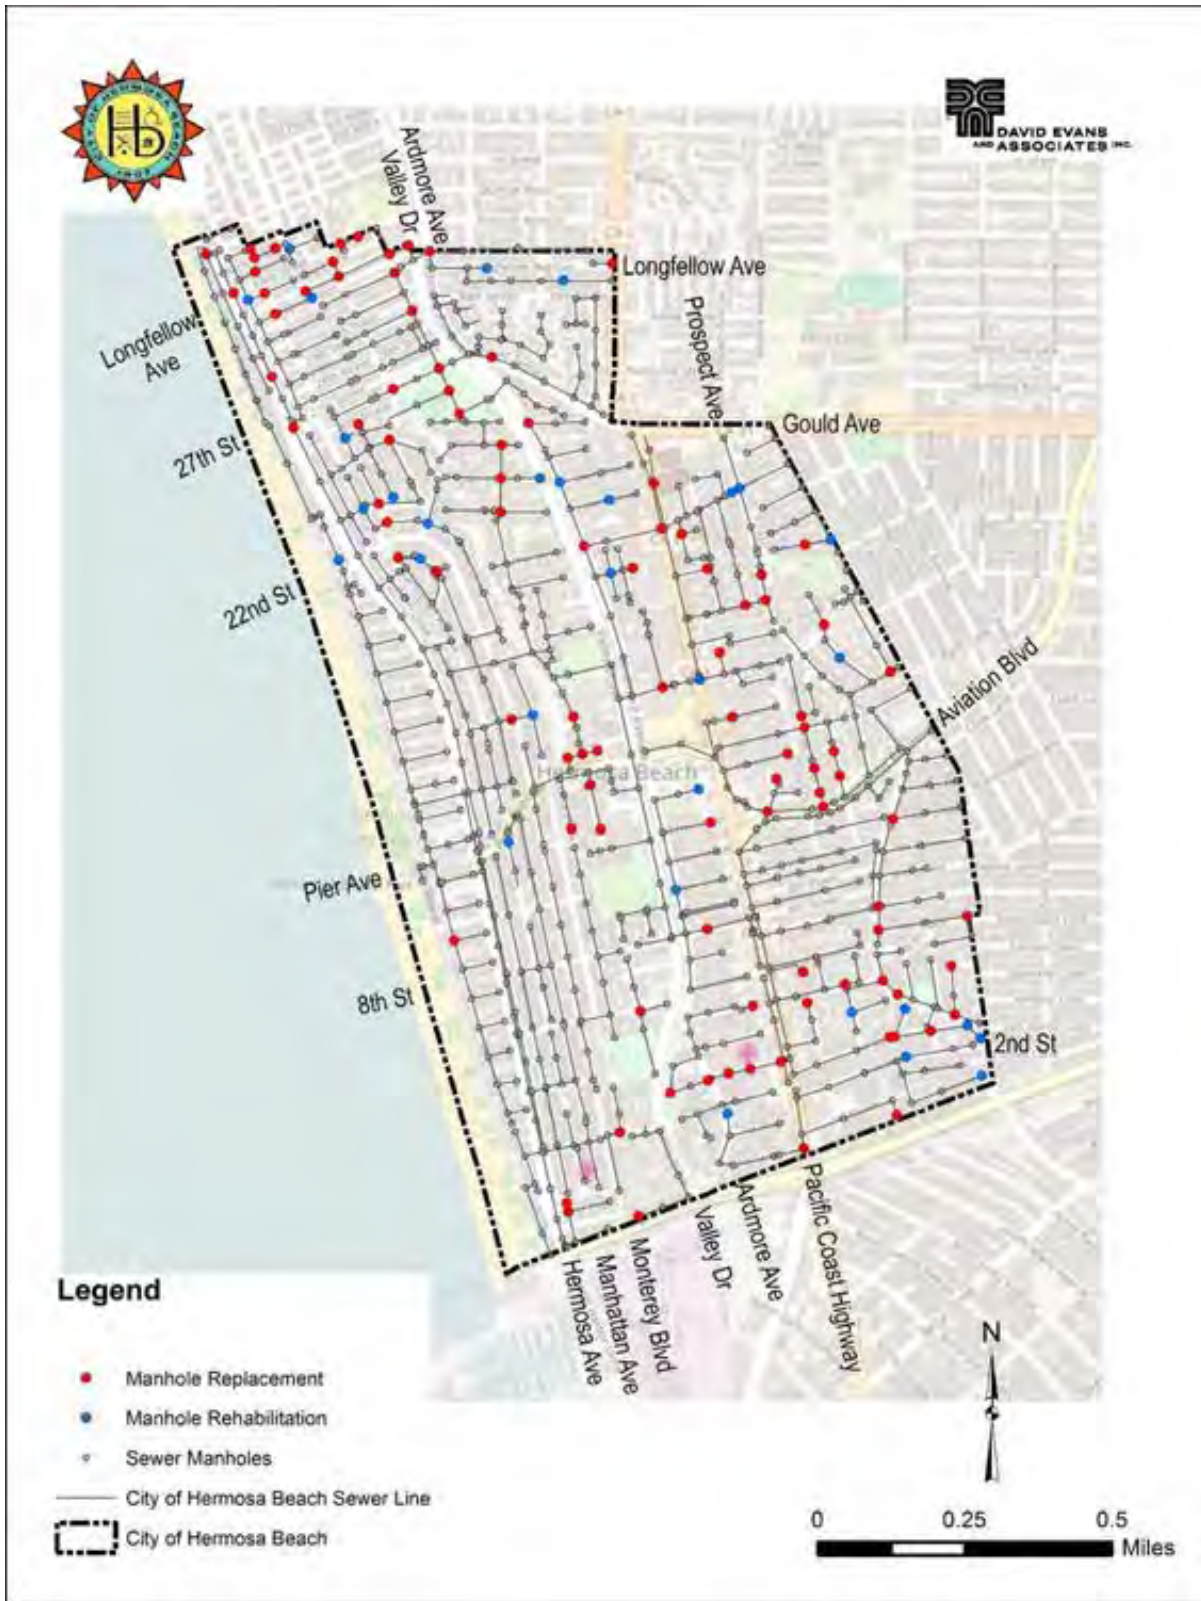
Figure 5-6: Manholes Recommended for Improvements

Table 5-4 lists the manholes recommended for improvements, and Figure 5-6 shows the manholes recommended for improvements

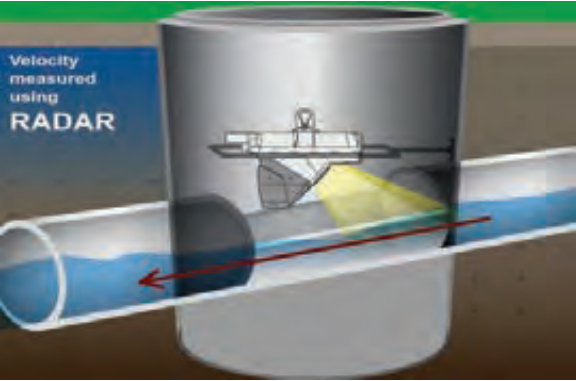
Flow Meter									
		Meter Depth: 64"									
		Map Coordinates: 33.867893, -118.398648									
		Moderate open channel hydraulics									
		<table border="1" style="width:100%; border-collapse: collapse;"> <tr> <th>Avg Velocity</th> <th>Avg Measured Level</th> <th colspan="2">Multiplier</th> </tr> <tr> <td>2.25 fps</td> <td>2.5"</td> <td colspan="2">1</td> </tr> </table>		Avg Velocity	Avg Measured Level	Multiplier		2.25 fps	2.5"	1	
Avg Velocity	Avg Measured Level	Multiplier

20.9	0	0	0								
		Notes									
		Could not open MH 0503, so upstream MH was used, which had noticeable root intrusion.									
		Traffic Safety									
		No traffic near MH during installation or removal.									
		Land Use									
		<table border="1" style="width:100%; border-collapse: collapse;"> <tr> <th>Residential</th> <th>Commercial</th> <th>Industrial</th> <th>Trunk</th> </tr> <tr> <td>X</td> <td></td> <td></td> <td></td> </tr> </table>		Residential	Commercial	Industrial	Trunk	X			
Residential	Commercial	Industrial	Trunk								
X											
		Manhole Depth 86"									
		Monitored Pipe Size 15"									
		Inner Pipe Size (In/Out) 15"/15"									
		Pipe Shape Round									
		Pipe Condition Fair									
		Manhole Material Brick									
		Silt 0									
		Velocity Profile Data *									
		Velocity Profile Taken 0.4 2-D									
		Sensor Offset 22.19"									
		Sensor Dist. to Crown 7.19"

Sensor Direction Upstream									
		Flow Heading South									
Technology

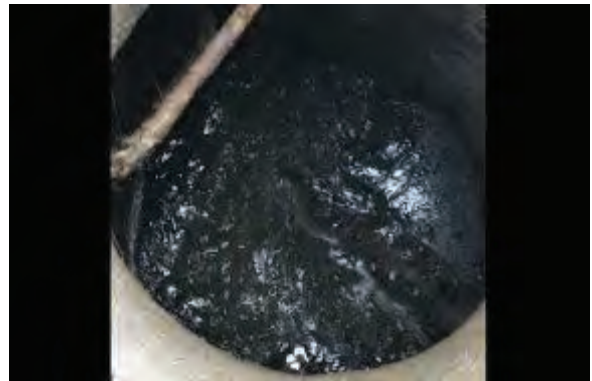
Manhole Hydraulics

Manhole Depth	115"
Monitored Pipe Size	15"
Inner Pipe Size (In/Out)	15"/15"
Pipe Shape	Round
Pipe Condition	Fair
Manhole Material	Brick
Silt	0
Velocity Profile Data	*
Velocity Profile Taken	0.4 2-D
Sensor Offset	23.71"
Sensor Dist. to Crown	8.71"
Sensor Direction	Downstream
Flow Heading	North

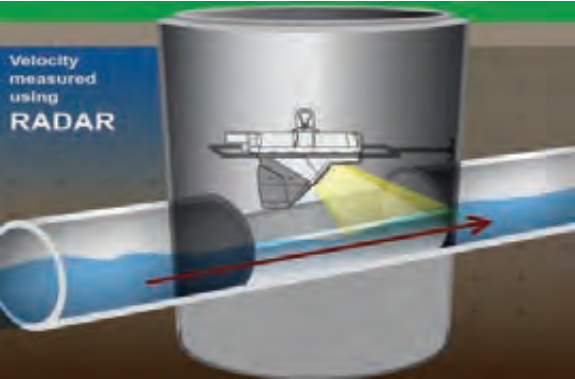
Flow Meter																											
	Meter Depth: 98"																											
	Map Coordinates: 33.866947, -118.396124																											
	Moderate open channel hydraulics																											
Technology

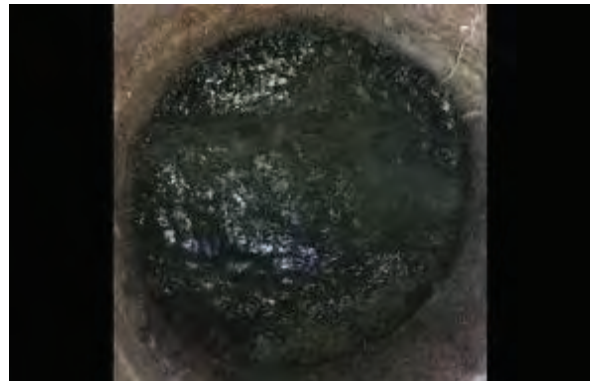
Manhole Hydraulics

Manhole Depth	99"
Monitored Pipe Size	8"
Inner Pipe Size (In/Out)	8"/8"
Pipe Shape	Round
Pipe Condition	Fair
Manhole Material	Concrete
Silt	0
Velocity Profile Data	*
Velocity Profile Taken	0.4 2-D
Sensor Offset	13.81"
Sensor Dist. to Crown	5.81"
Sensor Direction	Downstream
Flow Heading	West

Meter Depth: 85"		
Map Coordinates: 33.856401, -118.394364		
Turbulent open channel hydraulics due to quantity of inflow from upstream lines.		
Avg Velocity	Avg Measured Level	Multiplier
1.75 fps	4.5"	1

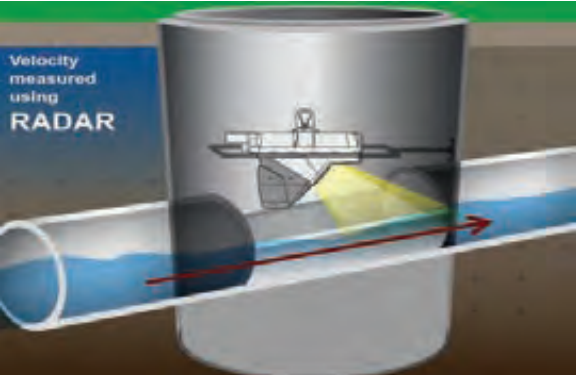
Flow Meter							
Meter Depth: 91" Map Coordinates: 33.852629, -118.397388 Moderate open channel hydraulics								
Technology

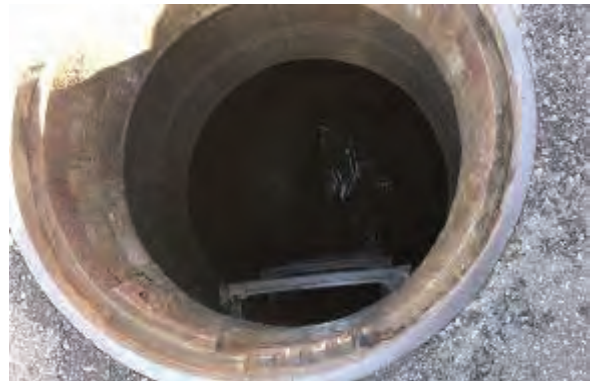
Manhole Hydraulics

<table border="1" style="width:100%; border-collapse: collapse;"> <thead> <tr> <th>Avg Velocity</th> <th>Avg Measured Level</th> <th>Multiplier</th> </tr> </thead> <tbody> <tr> <td>1.33 fps</td> <td>3.75"</td> <td>1</td> </tr> </tbody> </table>		Avg Velocity	Avg Measured Level	Multiplier	1.33 fps	3.75"	1
Avg Velocity	Avg Measured Level	Multiplier						
1.33 fps	3.75"	1						
Gas								
O2	H2S	CO	LEL					
20.9	0	0	0					
Notes *								
Traffic Safety Used cones, signs & a flagger.								
Land Use								
Residential	Commercial	Industrial	Trunk					
	X							
Manhole Depth		122"						
Monitored Pipe Size		24"						
Inner Pipe Size (In/Out)		24"/24"						
Pipe Shape		Round						
Pipe Condition		Good						
Manhole Material		Concrete						
Silt		0						
Velocity Profile Data		*						
Velocity Profile Taken		0.4 2-D						
Sensor Offset		31.43"						
Sensor Dist. to Crown		7.43"						
Sensor Direction		Downstream						
Flow Heading		South						
Sewer Plan

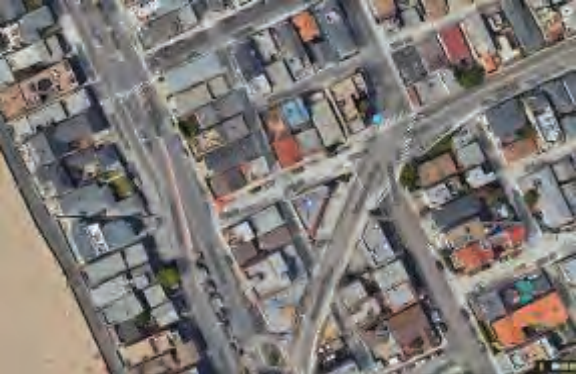
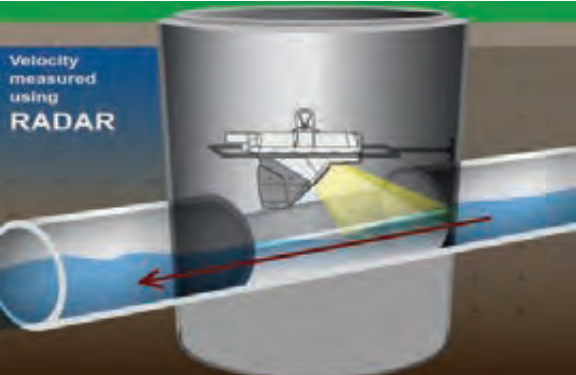
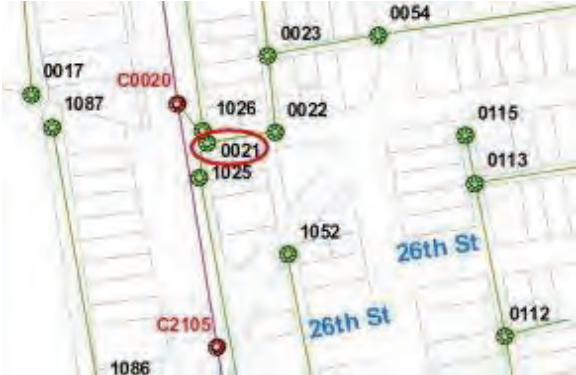
David Evans		~101 27th St	
2017.01-02 Site 7 27th St MH		Manhole No. 0021	
Access: Manhole is in westbound lane at intersection with Hermosa Av.	System Type: Sanitary <input checked="" type="checkbox"/> Storm <input type="checkbox"/>	Install Date: 1/18/2017	
Map

Flow Meter		
Meter Depth: 39" Map Coordinates: 33.872874, -118.405529 Moderate open channel hydraulics			
Avg Velocity 5.75 fps	Avg Measured Level 1.66"	Multiplier 1	
Gas			
O2 20.9	H2S 0	CO 0	
LEL 0			
Notes

*			
Traffic Safety			
Used cones, signs, & a flagger.			
Land Use			
Residential X	Commercial	Industrial	
Trunk			
Manhole Depth		54"	
Monitored Pipe Size		8"	
Inner Pipe Size (In/Out)		8"/8"	
Pipe Shape		Round	
Pipe Condition		Fair	
Manhole Material		Brick	
Silt		0	
Velocity Profile Data		*	
Velocity Profile Taken		0.4 2-D	
Sensor Offset		14.51"	
Sensor Dist. to Crown		6.51"	
Sensor Direction		Upstream	
Flow Heading		South	
Technology

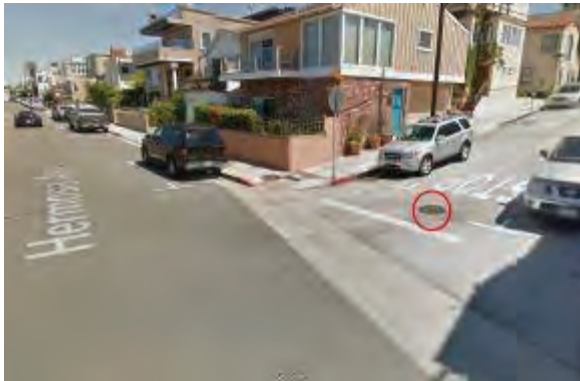
Site

~101 27th St

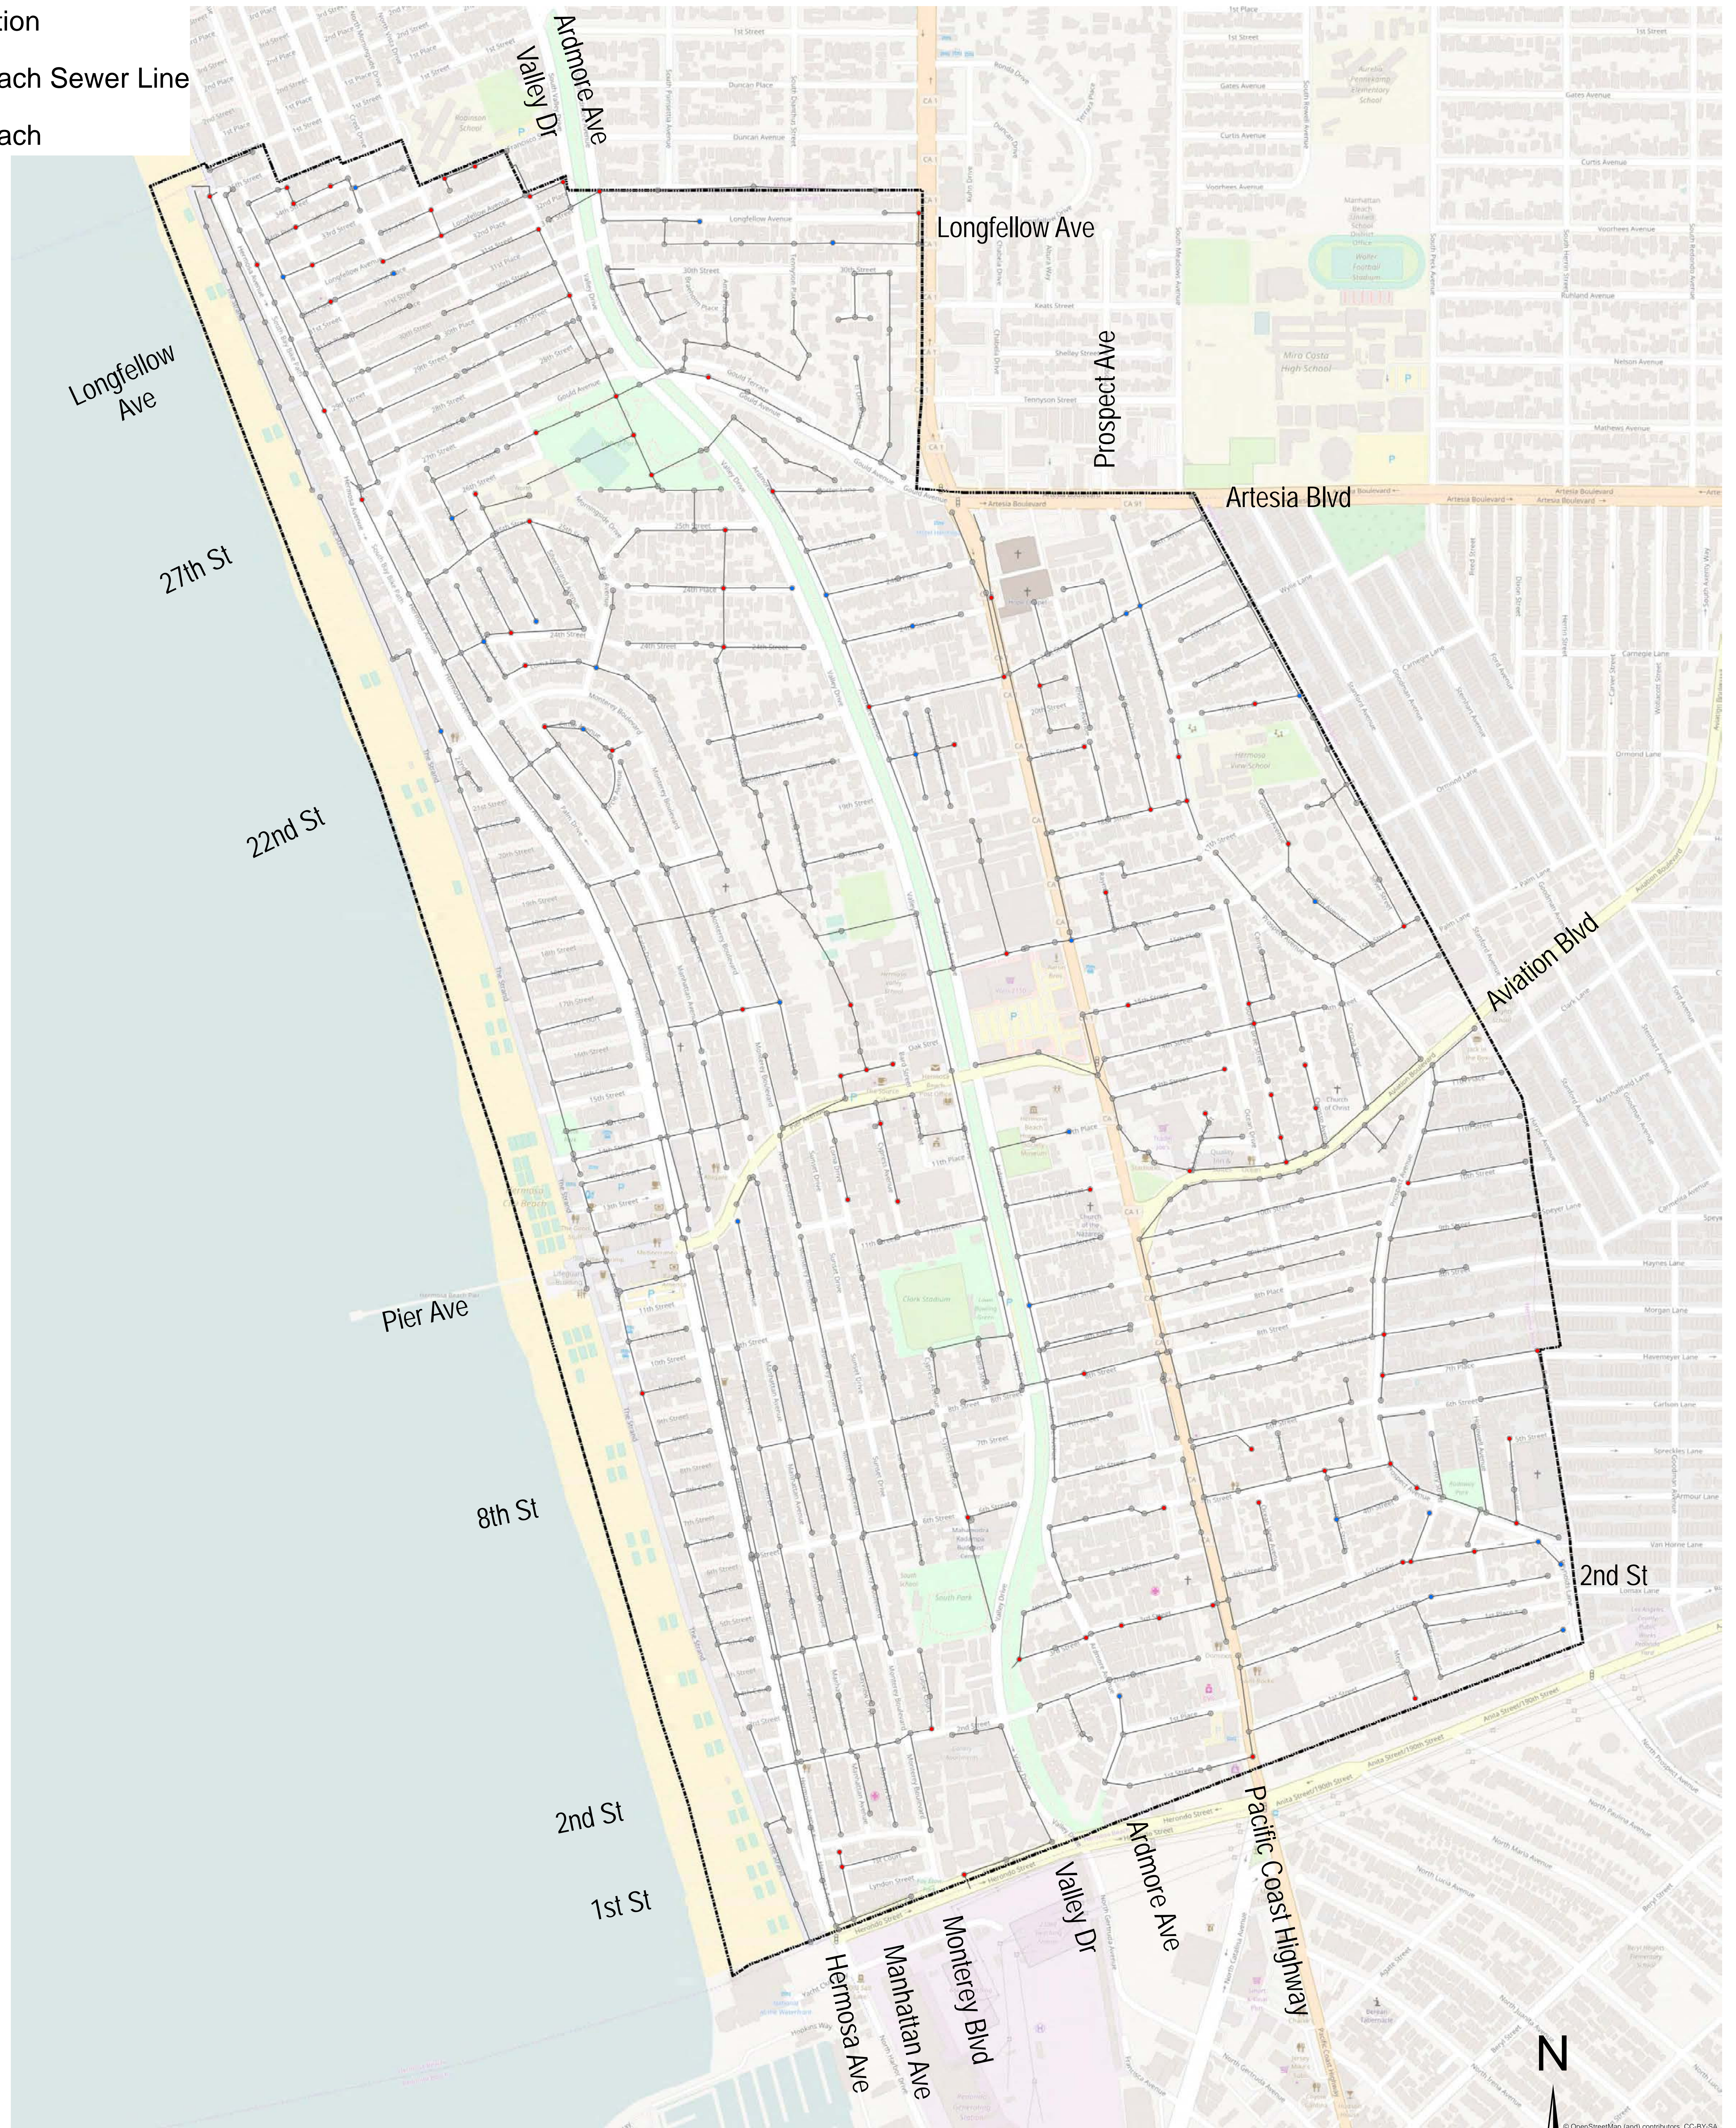
Manhole Replacement/Rehabilitation

- Manhole Replacement
- Manhole Rehabilitation
- City of Hermosa Beach Sewer Line
- ▭ City of Hermosa Beach
